# PROTECT2015

**The Fifth International Workshop on Performance, Protection,  
and Strengthening of Structures under Extreme Loading**

Strengthening and Repair of Las Vegas Distribution Center after a severe fire

By Luis Gonzalo Mejía C. P.E. MSc

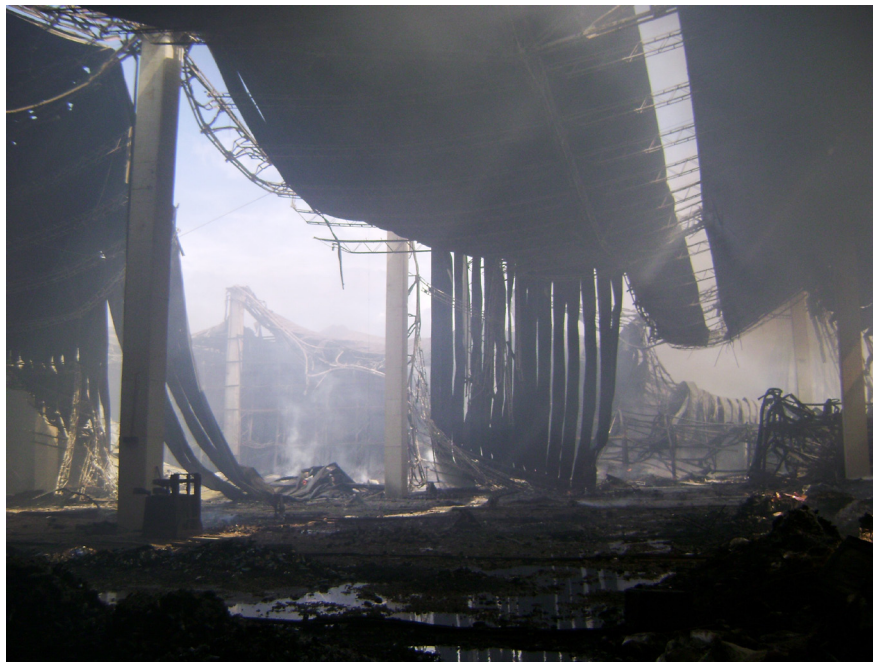
Figure 2. Warehouse after the fire

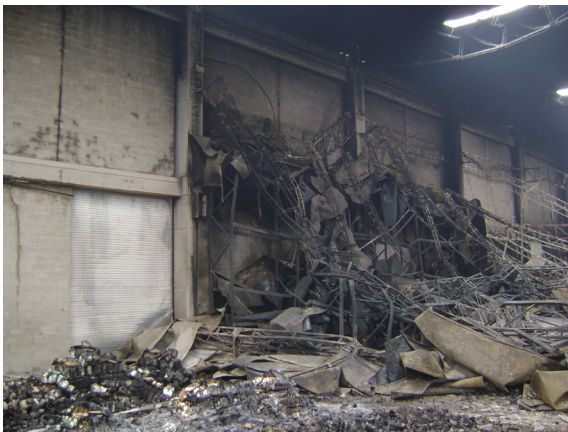
To understand the difficulties to get the required additional field information perhaps it is important to analyze the figure 5 that depict the real situation found in site: debris all around, varying degrees of damage depending on the presence of racks and the stored wares. Previously to the detailed investigation it was necessary to wait for the permission of the insurance companies and then to proceed to clean all debris. Only when all the conditions were appropriate, it was possible to begin the detailed investigation.

Figure 5. Varying degrees of damage

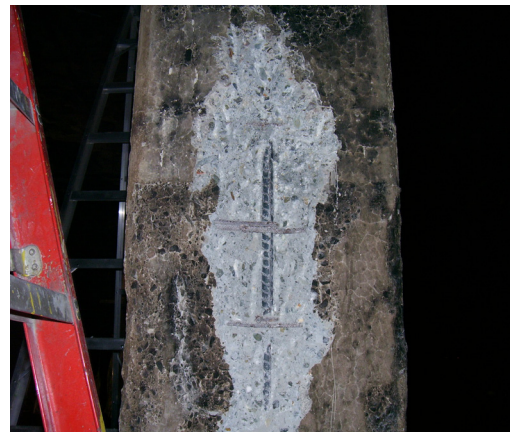
Of the greatest importance was the detailed visual inspection because she gave relevant information about which areas must be demolished or may be rehabilitated. As an example, from the detailed analysis of the situation depicted in figure 6, it was possible to gain very important information because the color of concrete in the surface indicates how high the temperature was and removing the cover it was possible to determine how deep penetrate the temperature in the structural member and it was possible to make an initial appreciation of the damage in the steel too.

Figure 6. Assessment of fire damage with the concrete color

After that, in the structural members that passed the detailed visual inspection, was necessary to proceed to take some cores (see figure 7) and samples of the steel (see figure 8) for laboratory testing. In figure 6 is noteworthy to see, that was no evidence from a slip between the steel and the concrete, in other words, the adherence was not impaired.

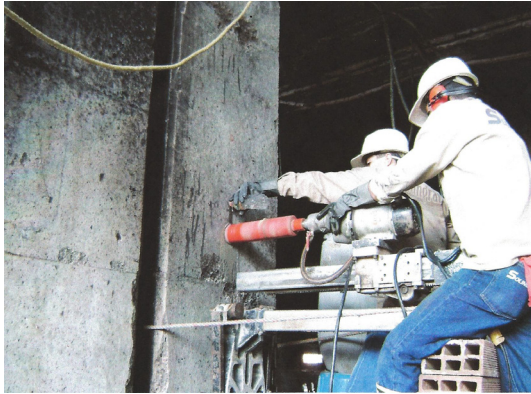
Figure 7. Extracting concrete cores

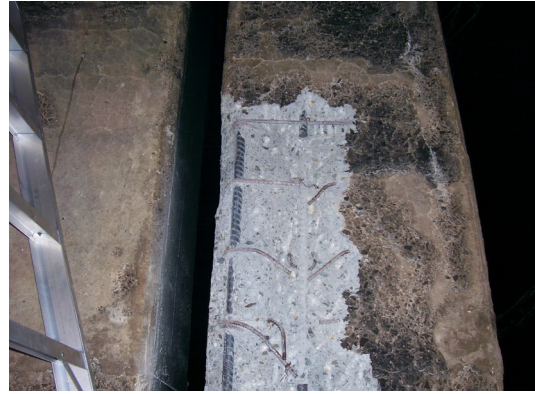
Figure 8. Taken of samples of steel for laboratory testing

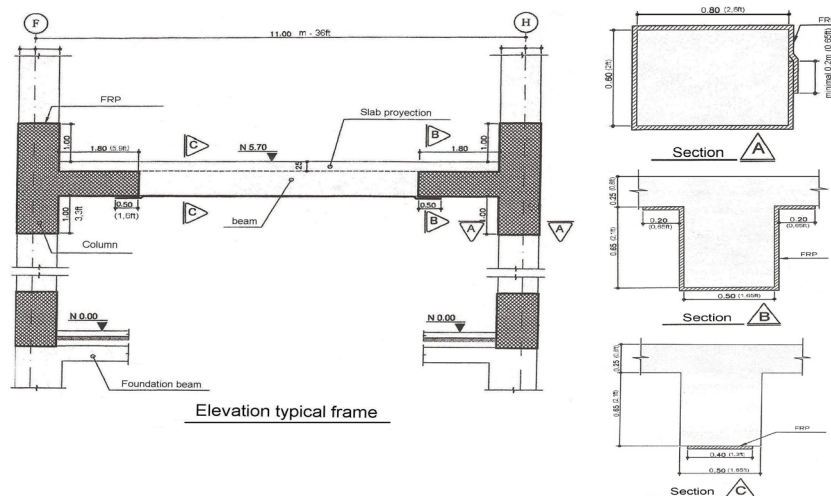
The detailed investigation concludes that the mayor part of the central and north areas of the warehouse must be demolished. Although the construction materials and the construction methods have no objection, the very high temperatures over 1112 °F (600 °C) were very destructive for the structural elements and for this reason a controlled demolition of the structure using explosives were made. Only the bakery could be repaired using extensively external reinforcement (FRP) accordingly the recommendations from [4], [5] and epoxy injection [6] (see figure 9).

Figure 9. Typical FRP reinforcement of damaged frames

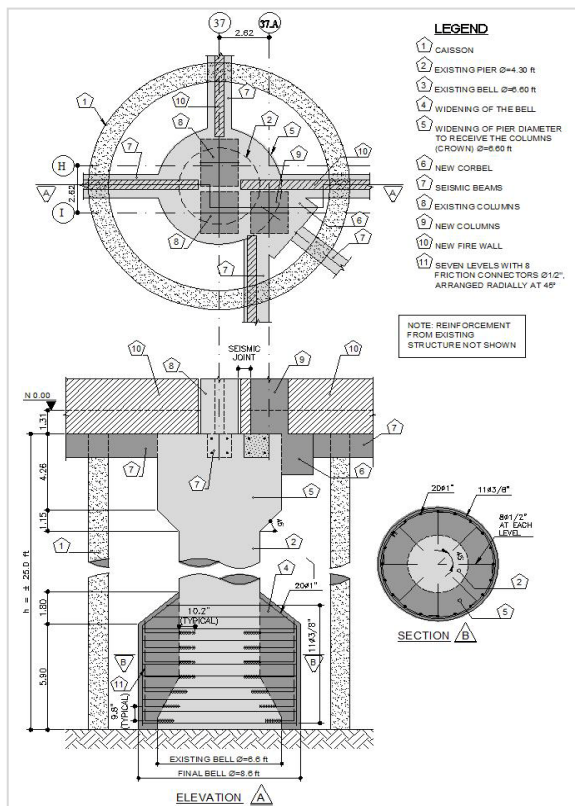
Figure 10. Widening of the bell (Plant and elevation)

For this reason was necessary to enlarge the bells (see figure 10) and to use a variety of corbels anchored with epoxy resins. The figures 11 to 13 show one example of the variety of solutions that should be implemented to attain the new stringent safety requirements. The figures 14 and 15 show the construction works required to the enlargement of the bells and the anchoring of the corbels for the new columns.

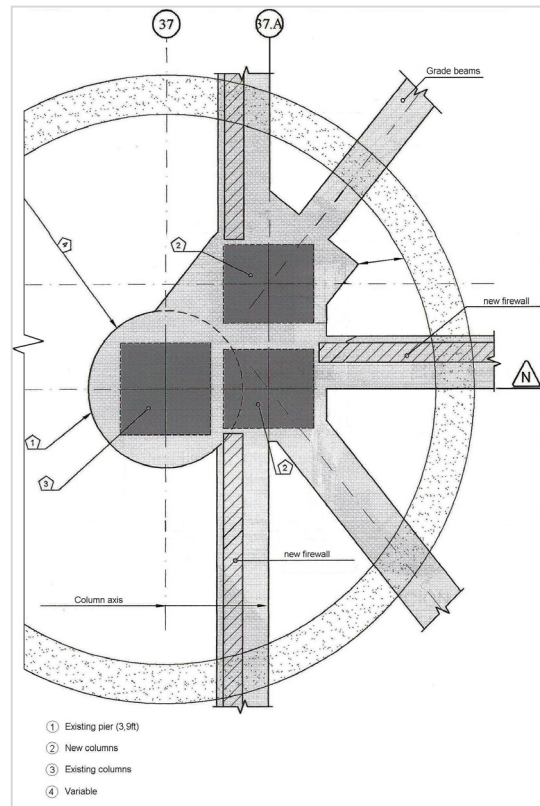
Figure 11. Detail showing new corbels, columns and fire walls

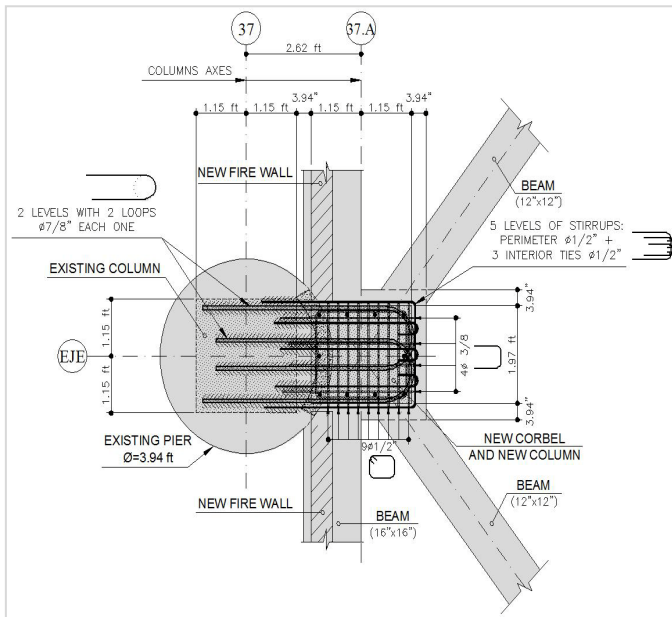
Figure 12. Pier with one corbel

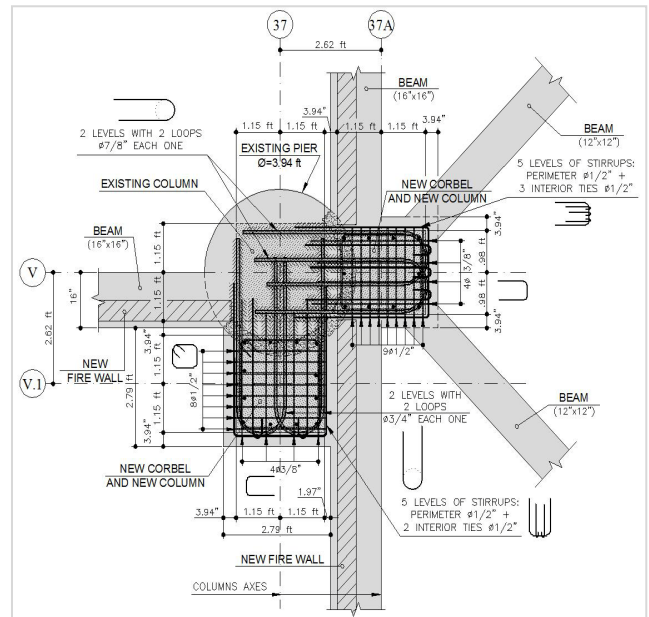
Figure 13. Pier with two corbels

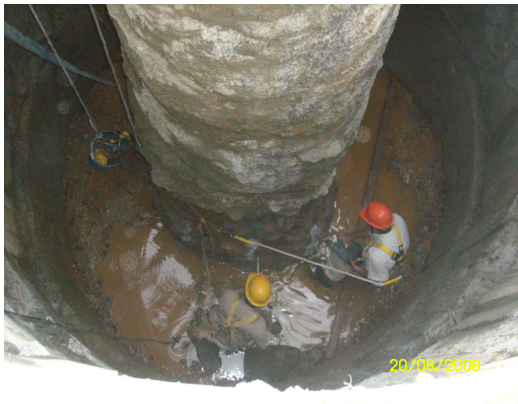
Figure 14. Construction of bell enlargement

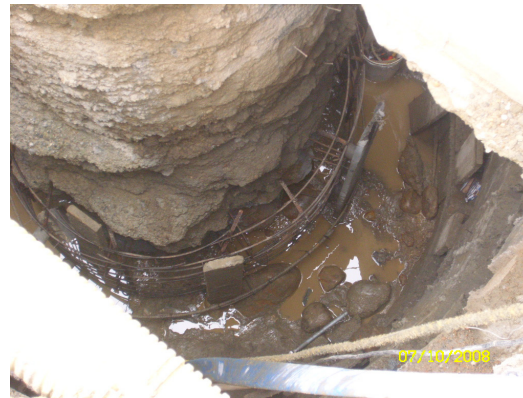
Figure 15. Placing of the new bell reinforcement

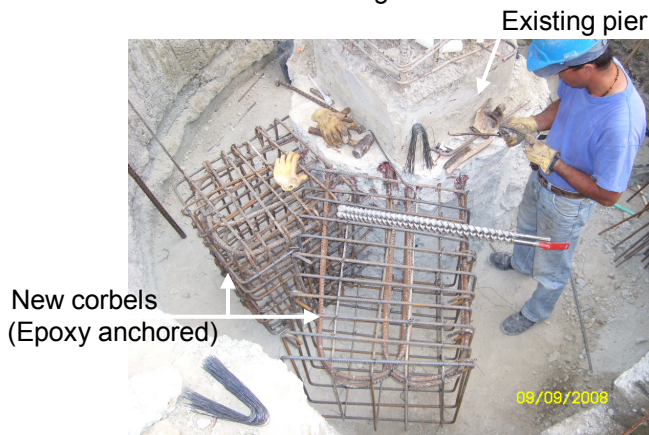
Figure 16. Epoxy anchoring of the reinforcement for the new corbels

The figures 16 and 17 shown some construction stages related with the strengthening of foundations and the anchoring of the corbels reinforcement.

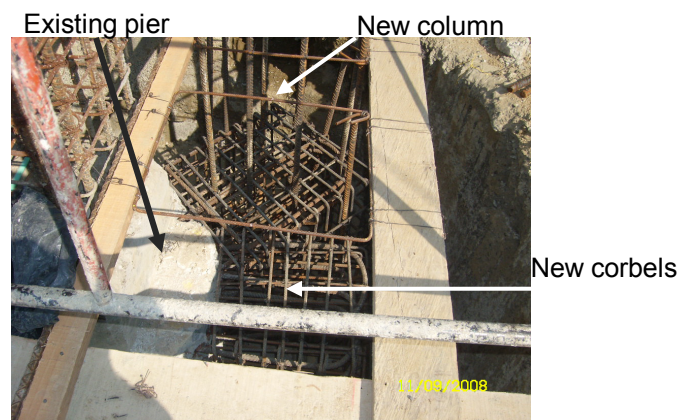
Figure 17. Placing of the new column reinforcement
