# World Housing Encyclopedia Report

Country: Colombia

Housing Type: Gravity concrete frame buildings (predating seismic codes).

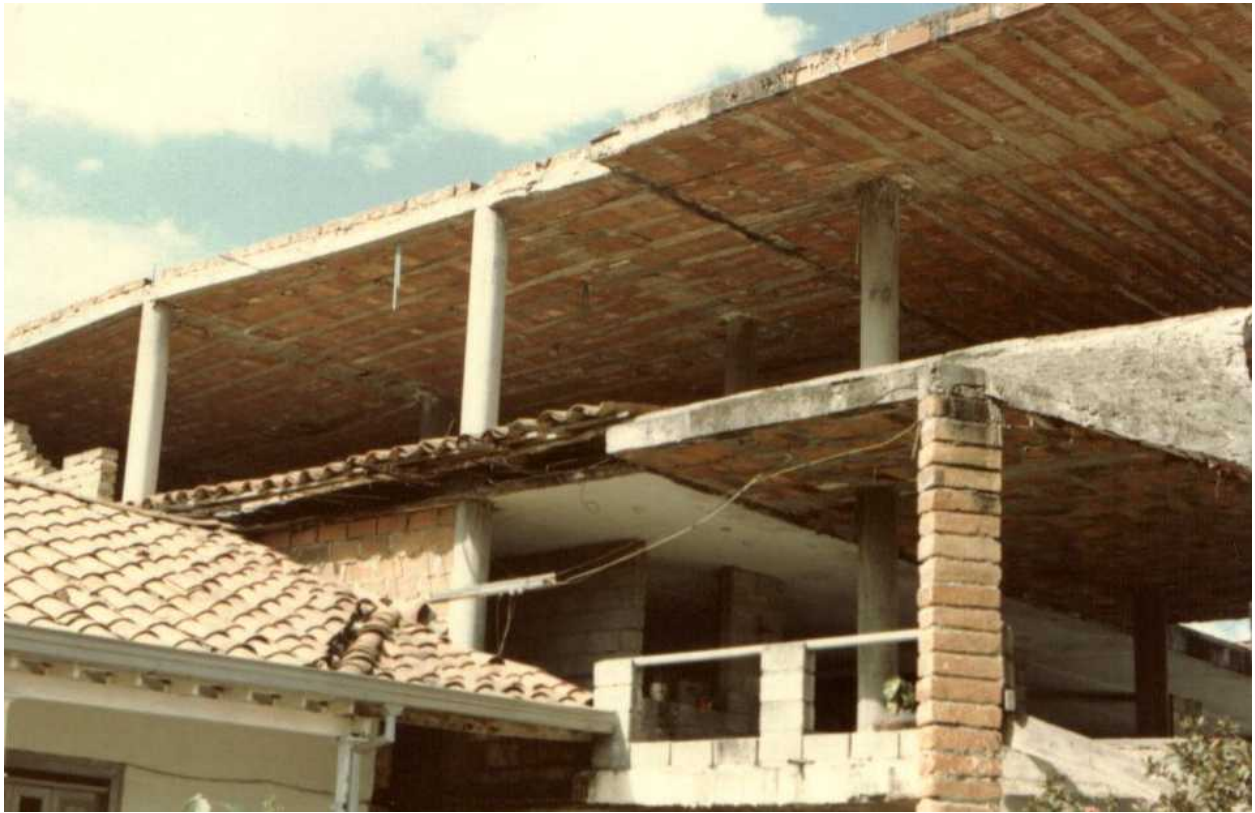
*FIGURE 1: Typical Building*

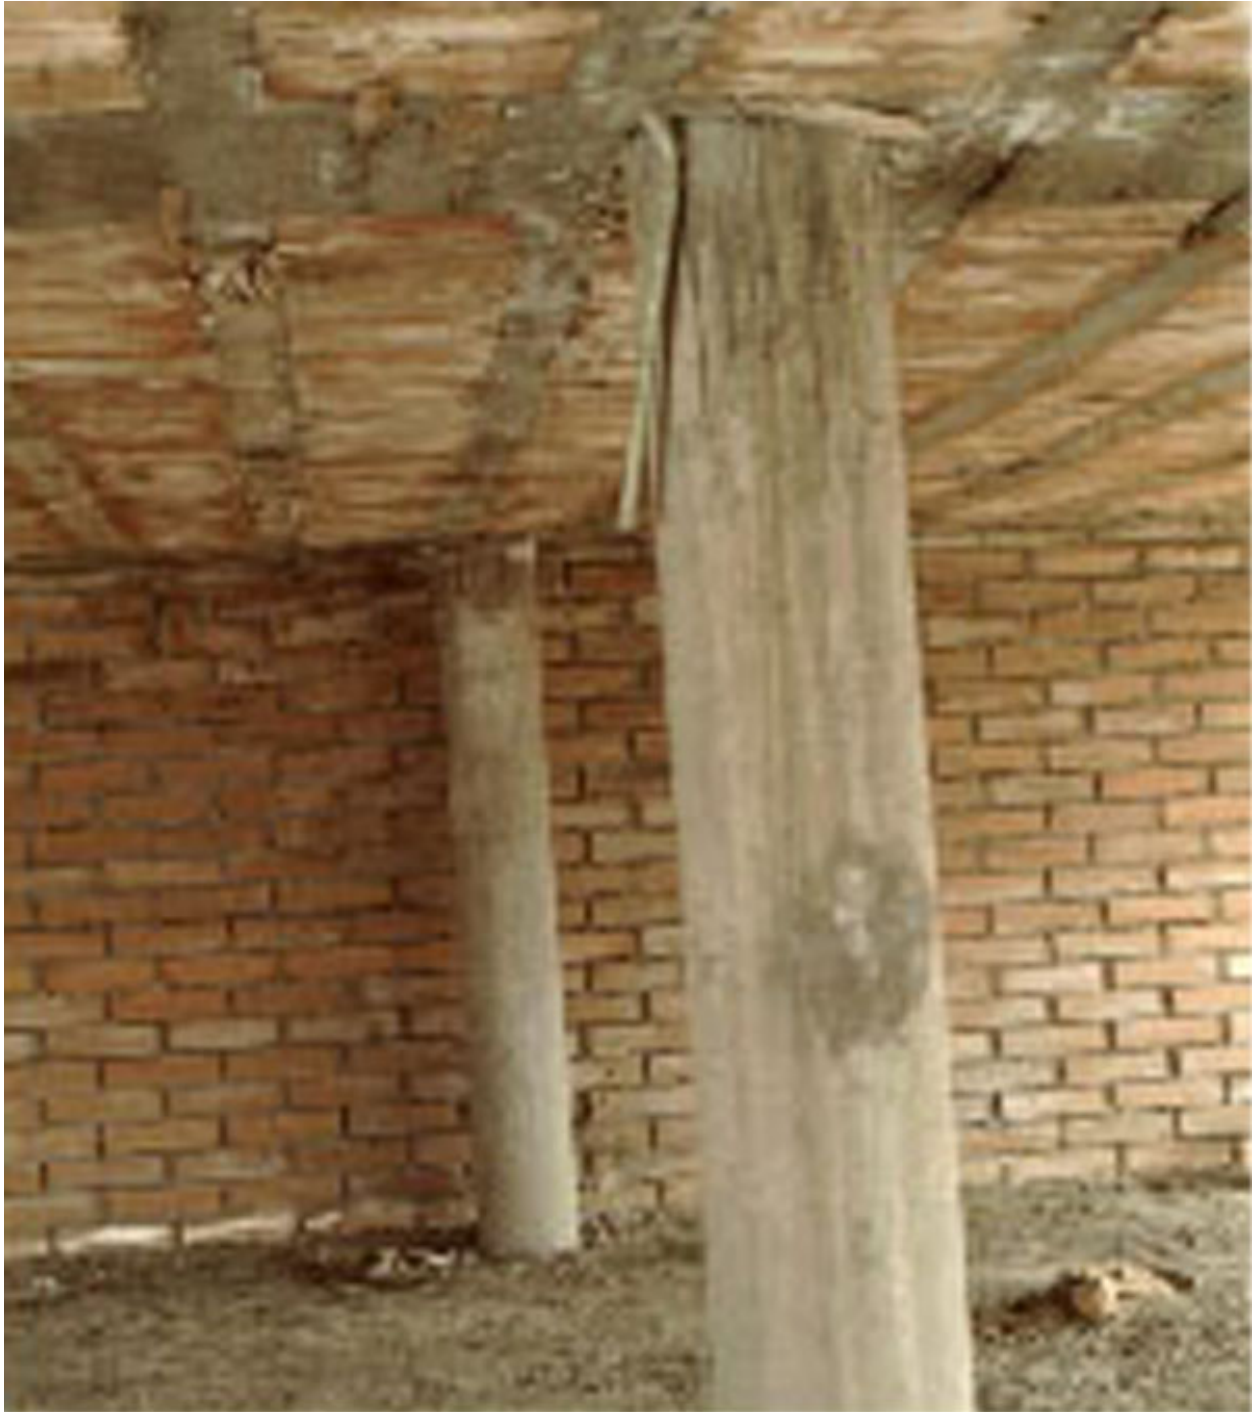
*FIGURE 5A: Poor Construction Practice- Beams constructed in one direction only.*

*Additional Comments:* Typical seismic deficiencies related to this type of construction, mainly due to poor construction practices and workmanship, are illustrated in the FIGURES 5A, 5B, 5C, 5D and 5E.

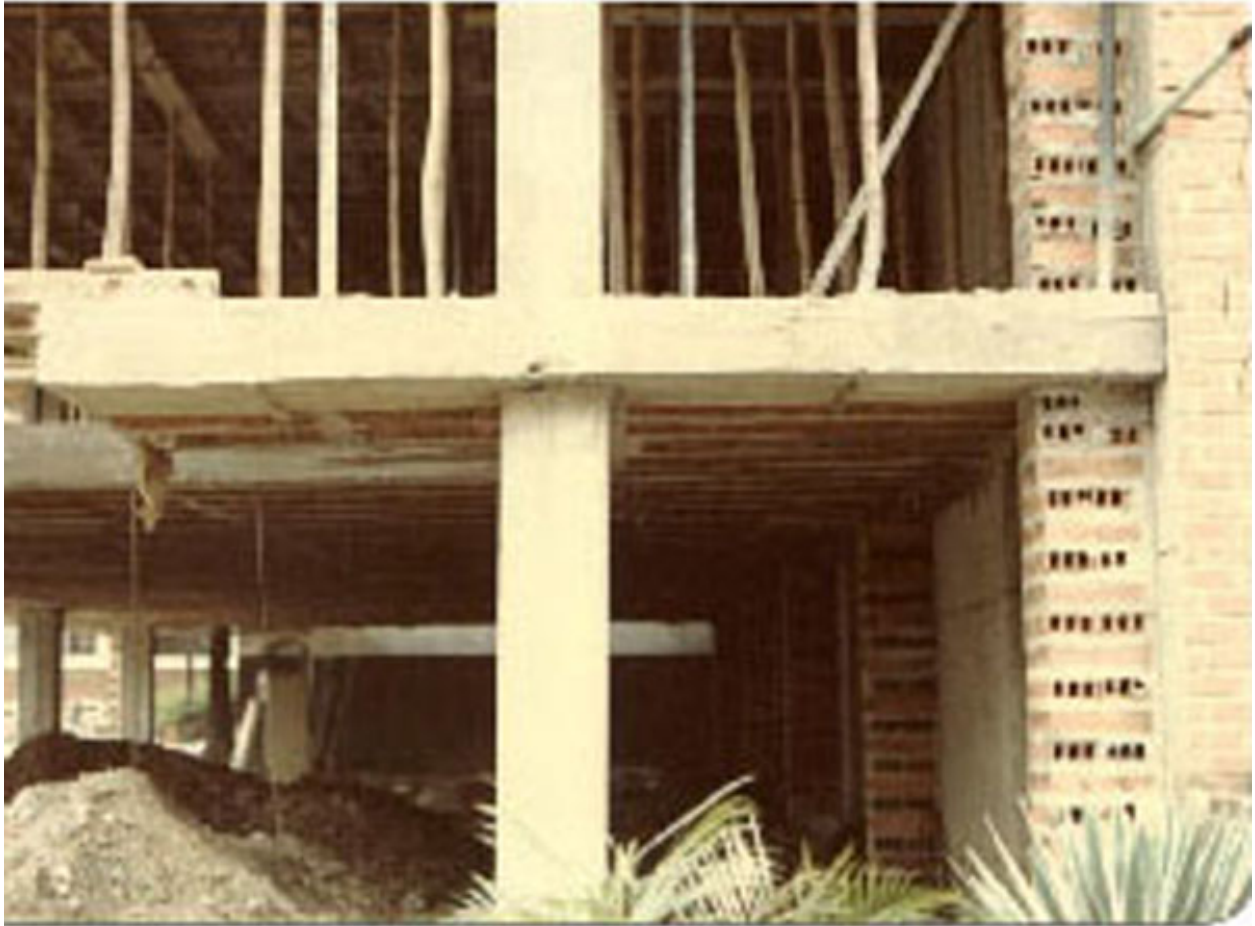
*FIGURE 5D: Poor Design - Combination of Concrete Frames and Unreinforced Masonry Walls or Pilasters*

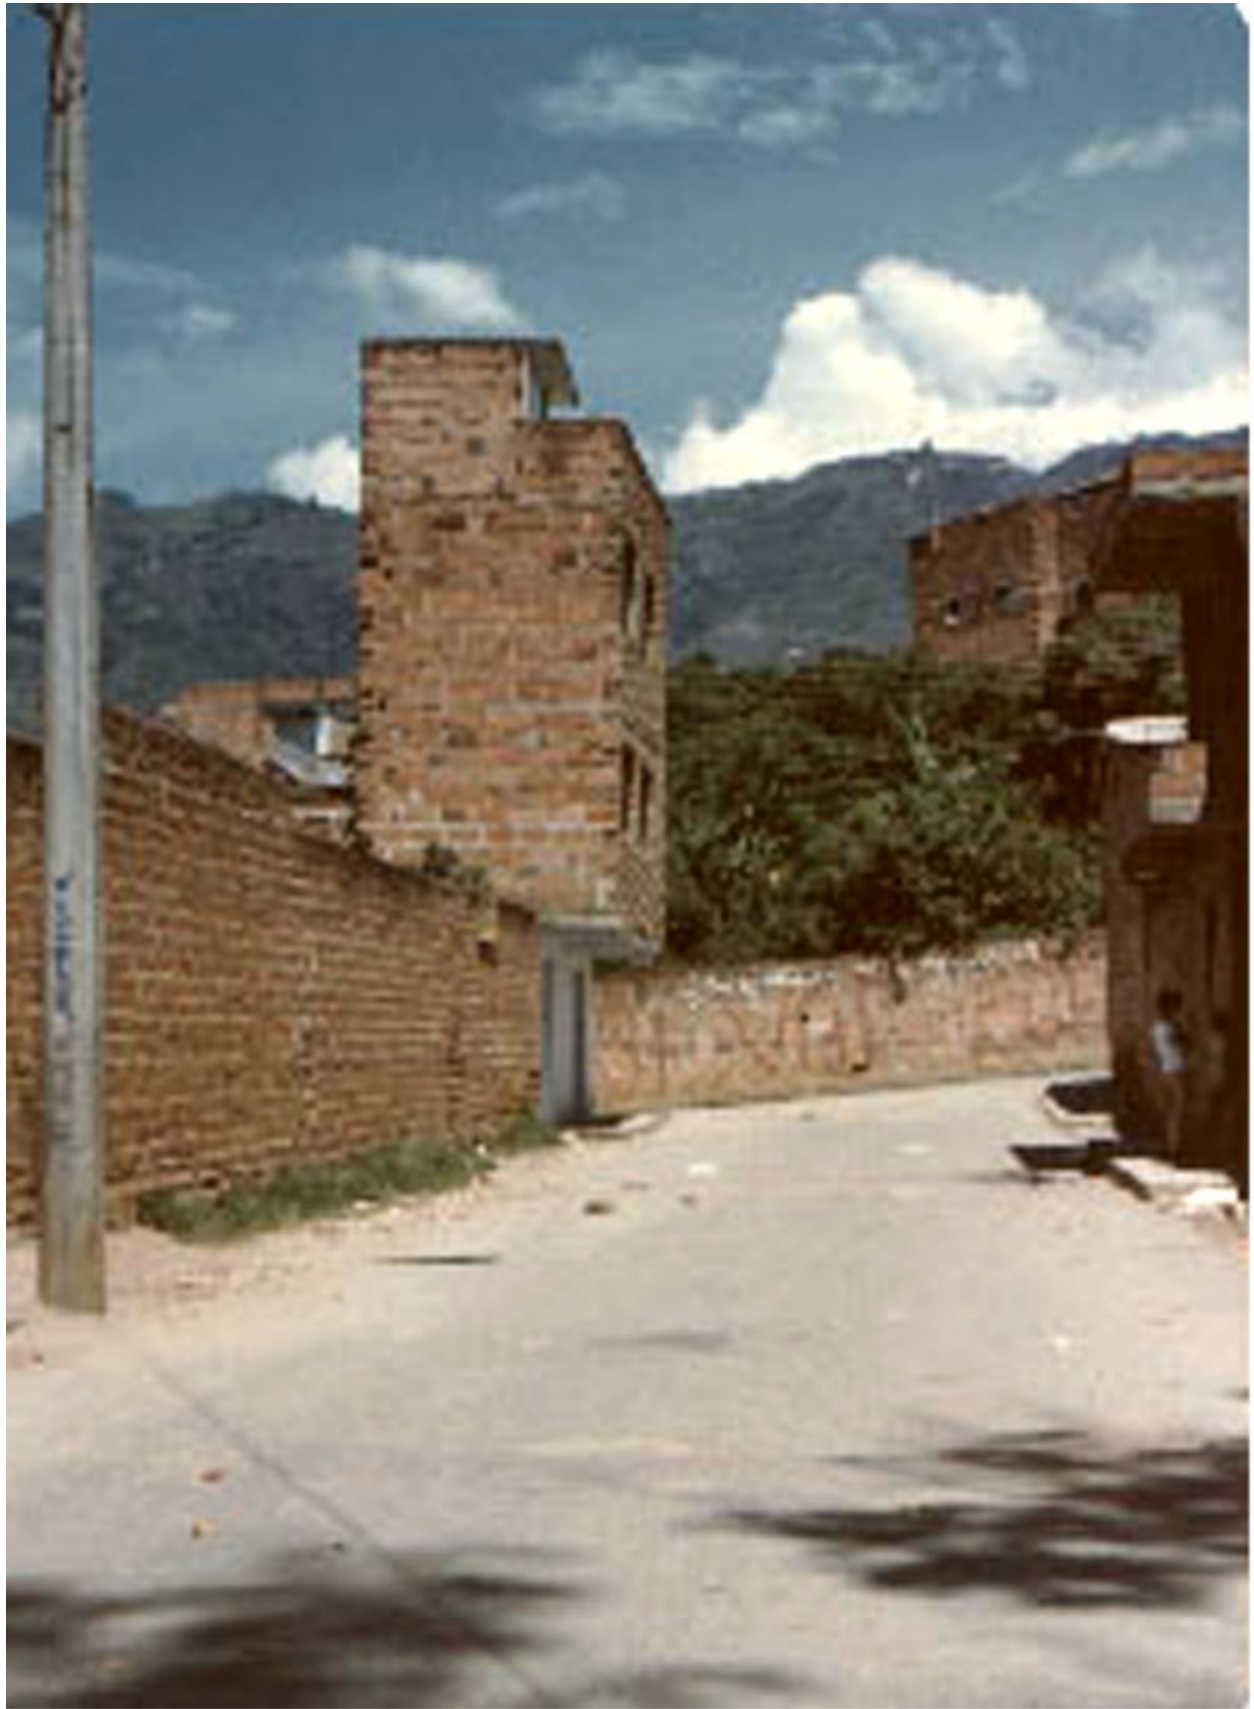
*FIGURE 5F: Playing with the laws of equilibrium*

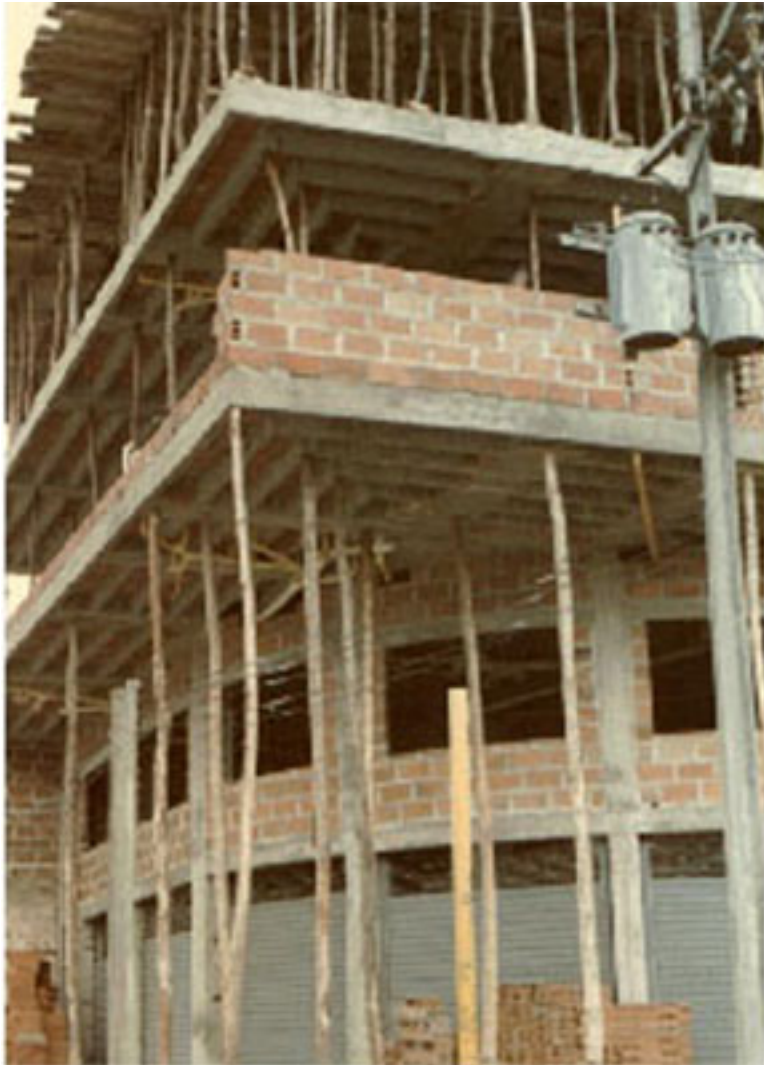
*FIGURE 5G: Playing with the laws of equilibrium*

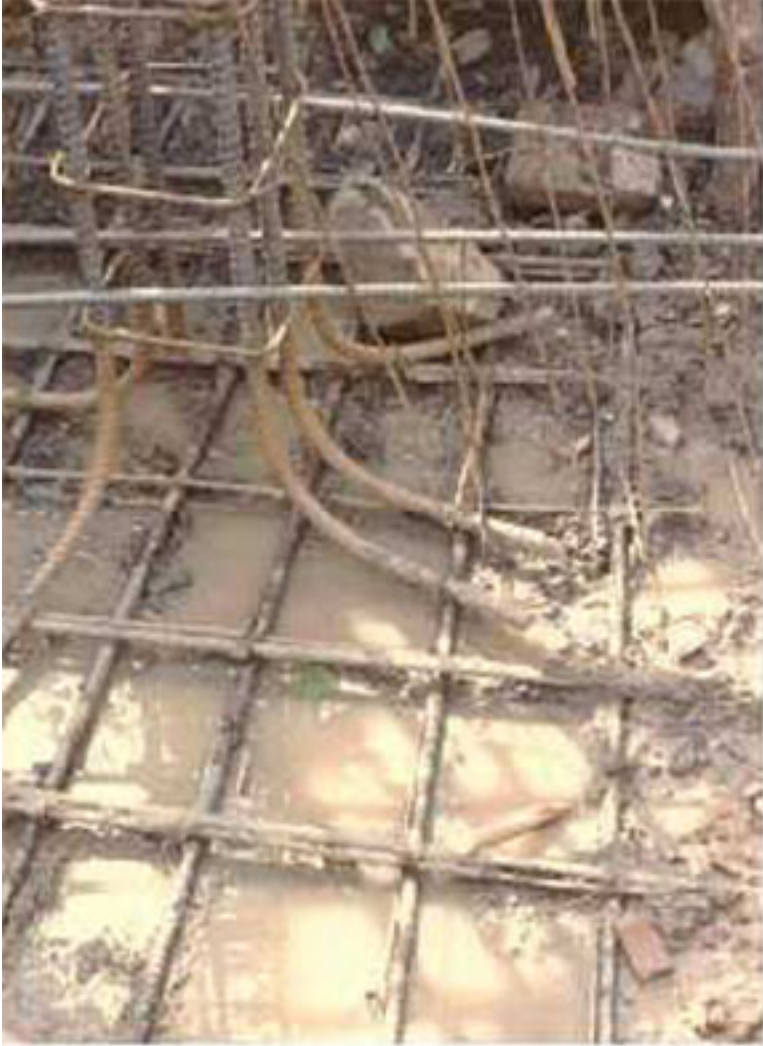
*FIGURE 5H: Poor Workmanship - Dirty groundwork and inappropriate column and bar anchorage*

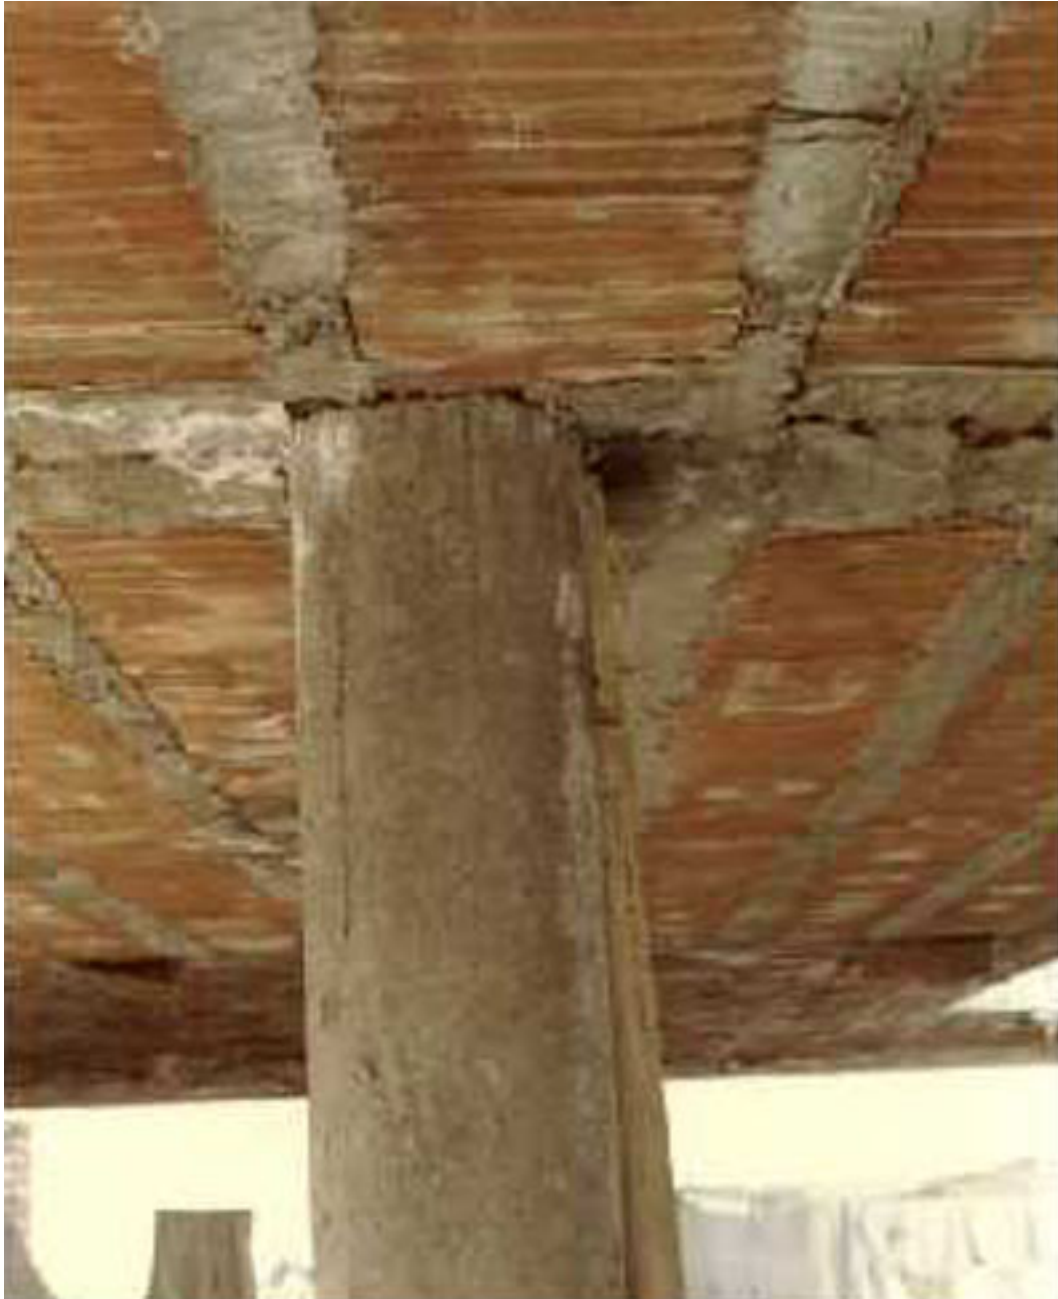
*FIGURE 5I: Poor Construction Practice-Drains running across the girders. Stirrups are removed to allow for the pipeline passage*

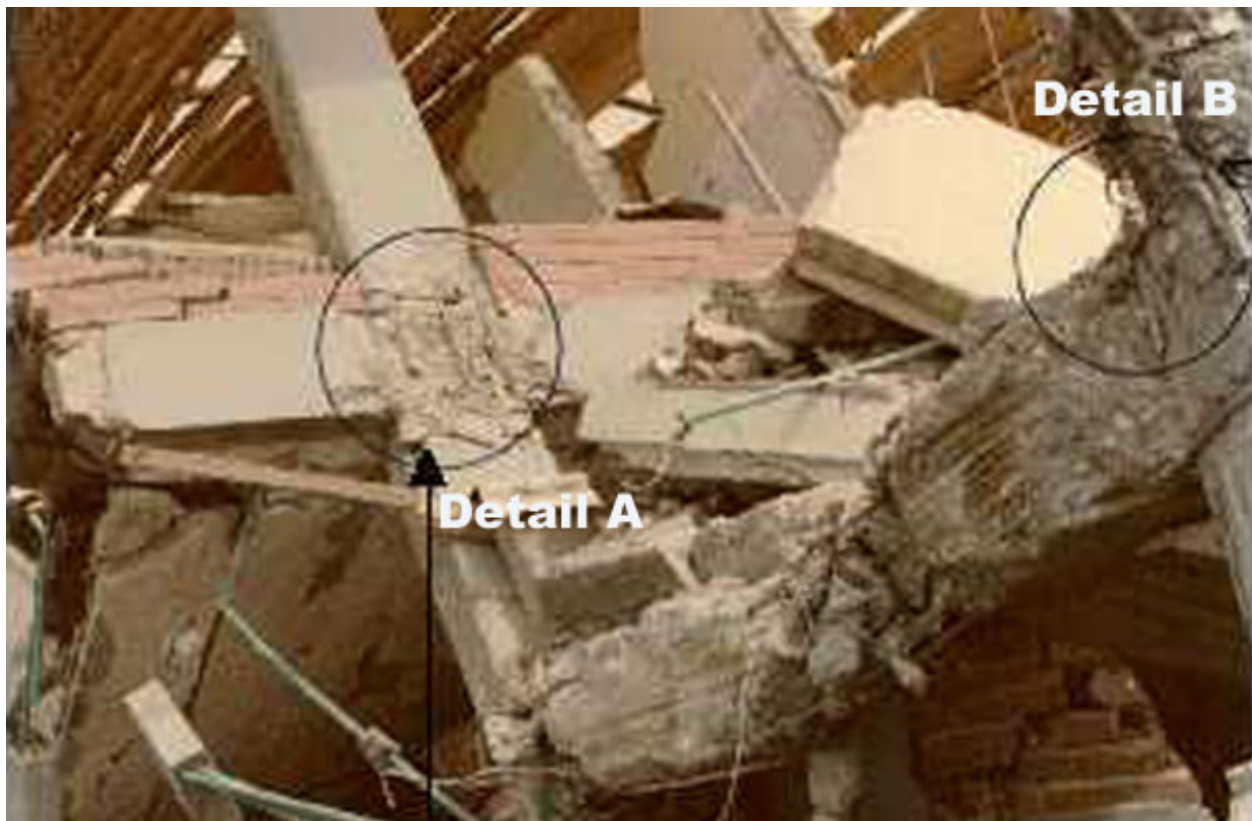
*FIGURE 6B: Earthquake Damage- Reinforcement splices in the joint zone (Detail A).*

*Additional Comments:* Most buildings of this type collapsed, killing the inhabitants, especially in the areas with pronounced soil amplification. Typical patterns of earthquake damage are illustrated in FIGURES 6A, 6B, 6C, 6D, and 6E. The figures confirm the importance of good construction practice and its impact on seismic performance.

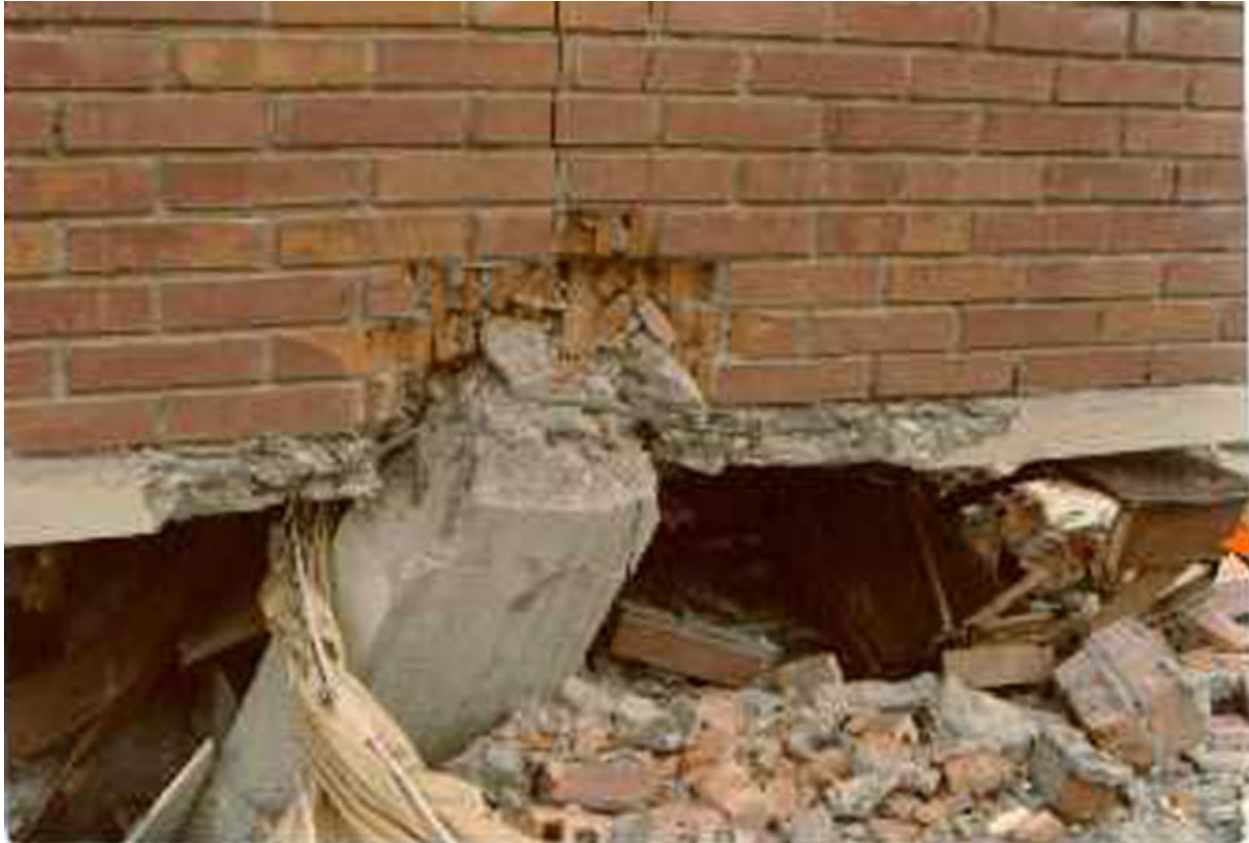
*FIGURE 6D: Earthquake Damage- Inadequate longitudinal and transverse reinforcement (note the collapsed first story)*

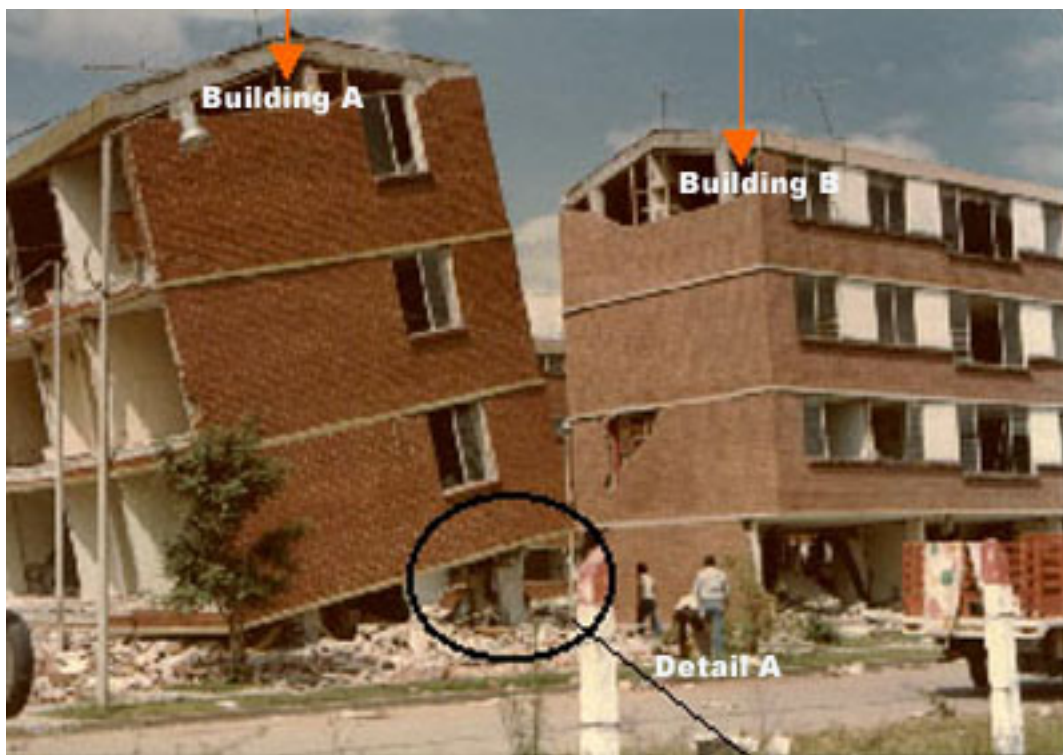
*FIGURE 6E: Collapsed building; Detail A shows too widely spaced stirrups*

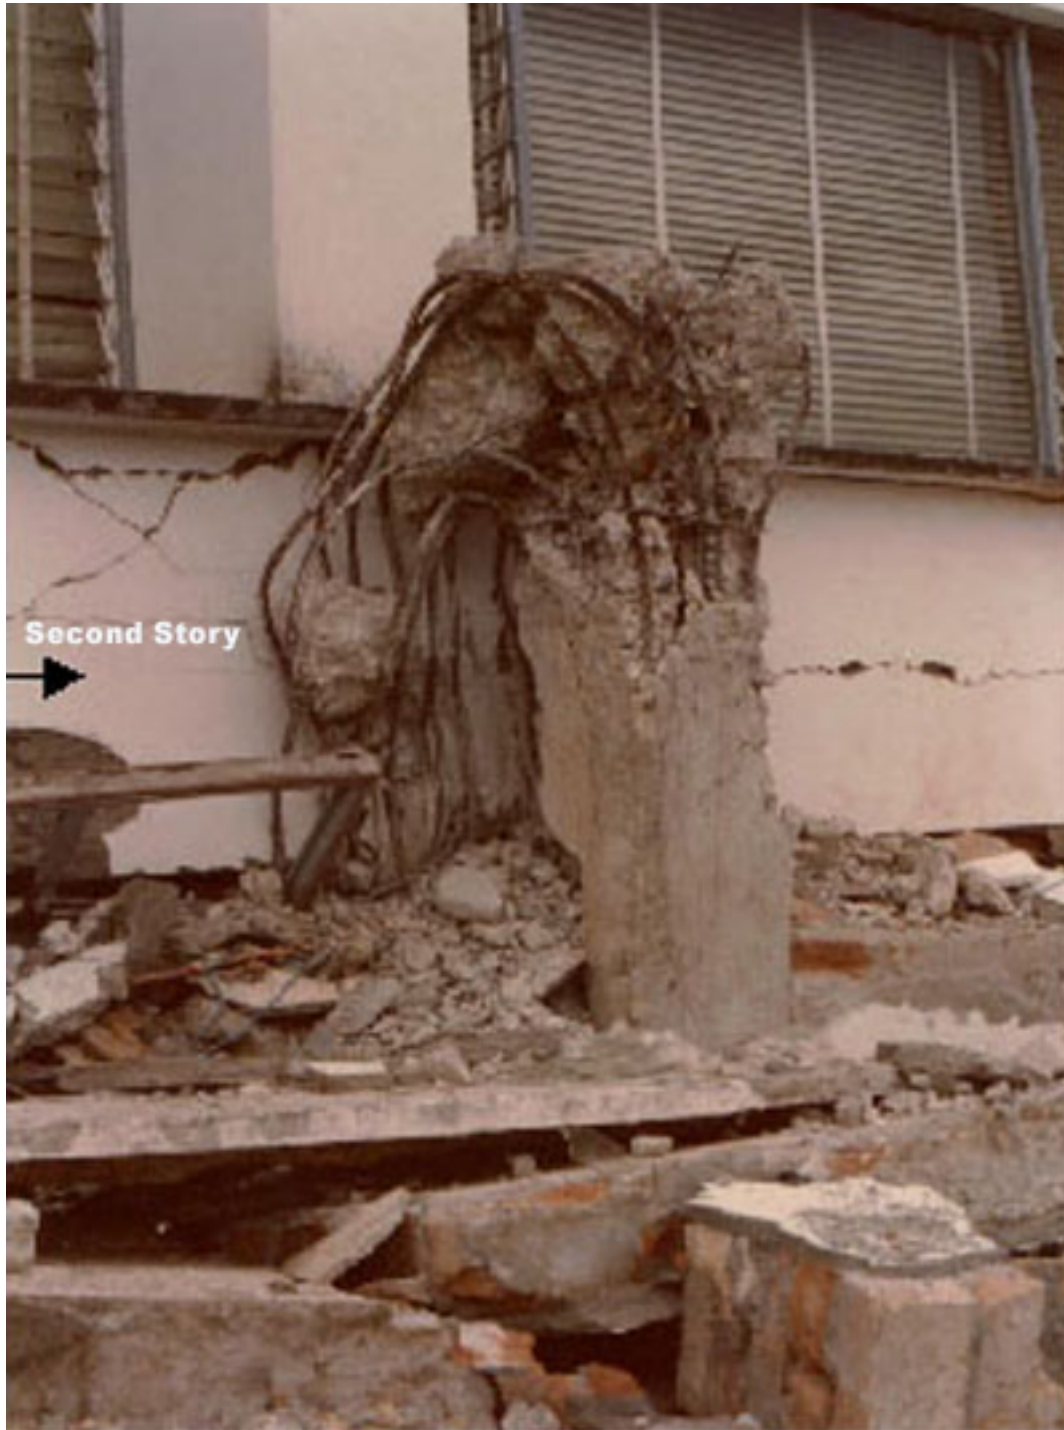
*FIGURE 6G: Collapsed 3-story building. (note the total lateral drift between the 2nd and 3rd floor)*

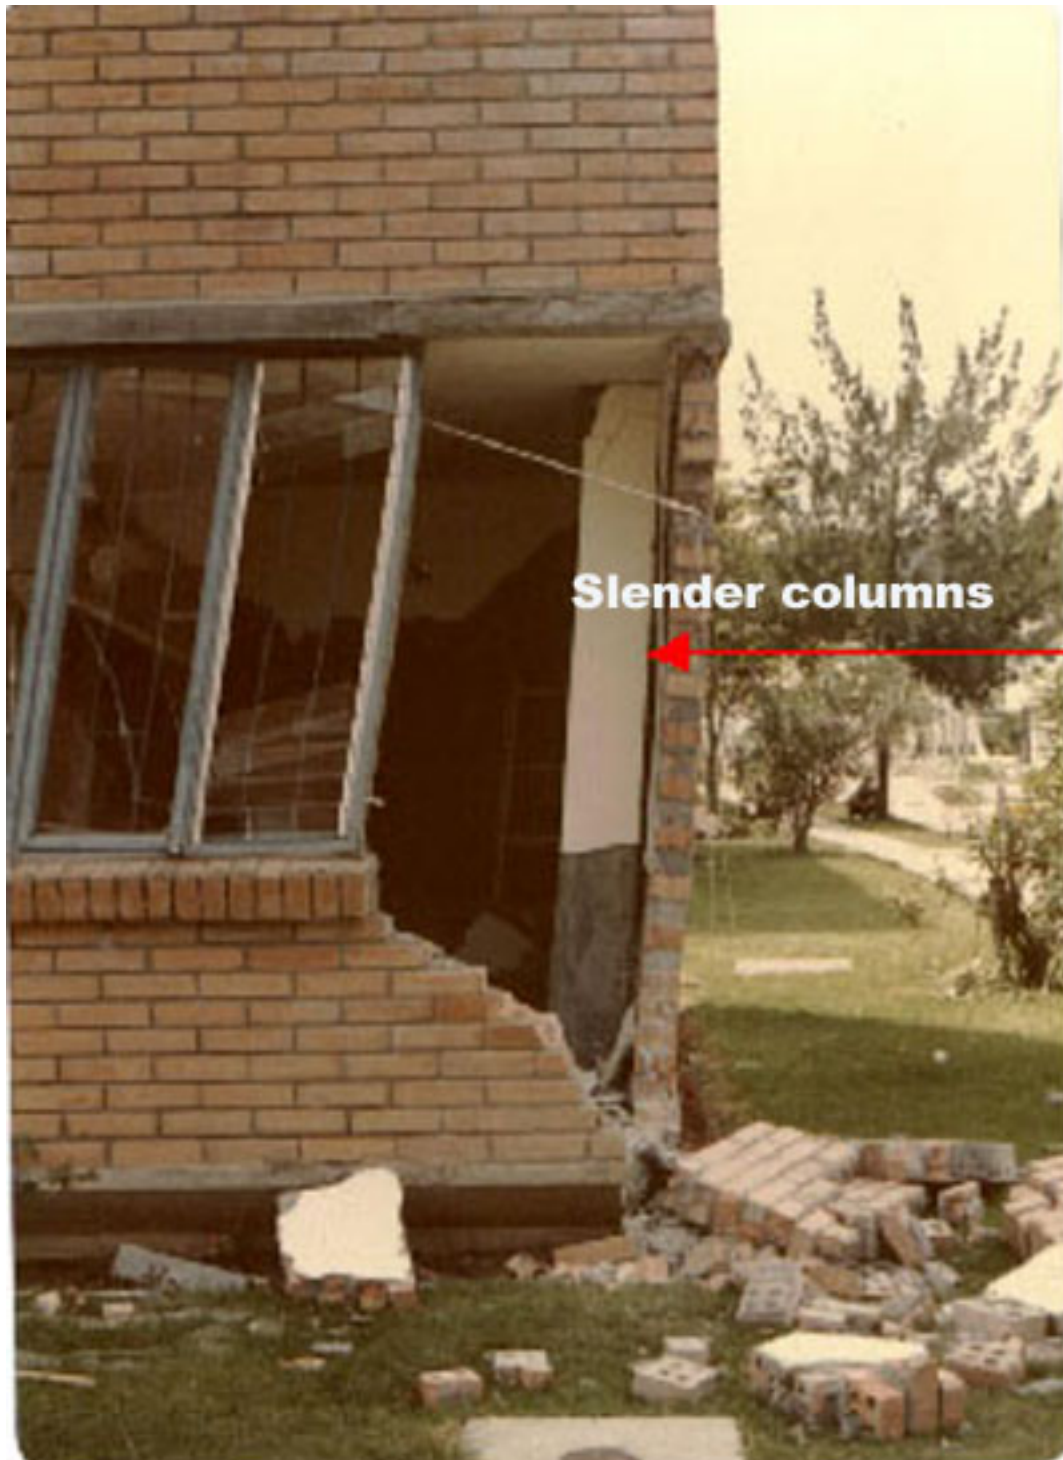
*FIGURE 6I: Earthquake Damage- Very Slender Columns*

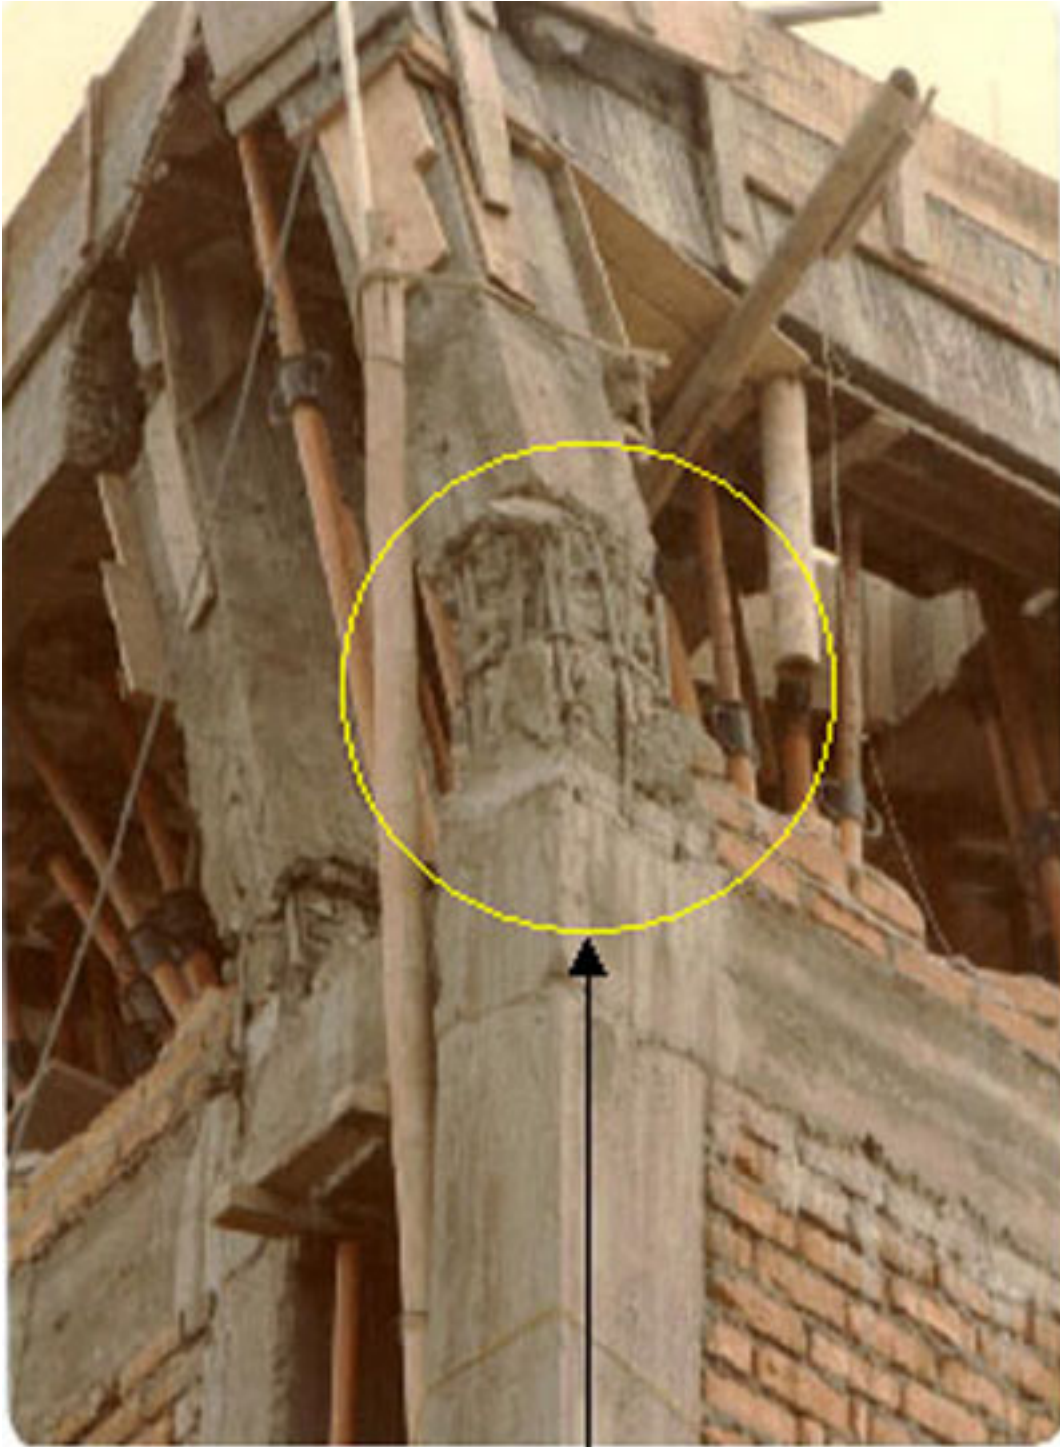
*FIGURE 6J: Earthquake Damage-Inadequate Column Splices*

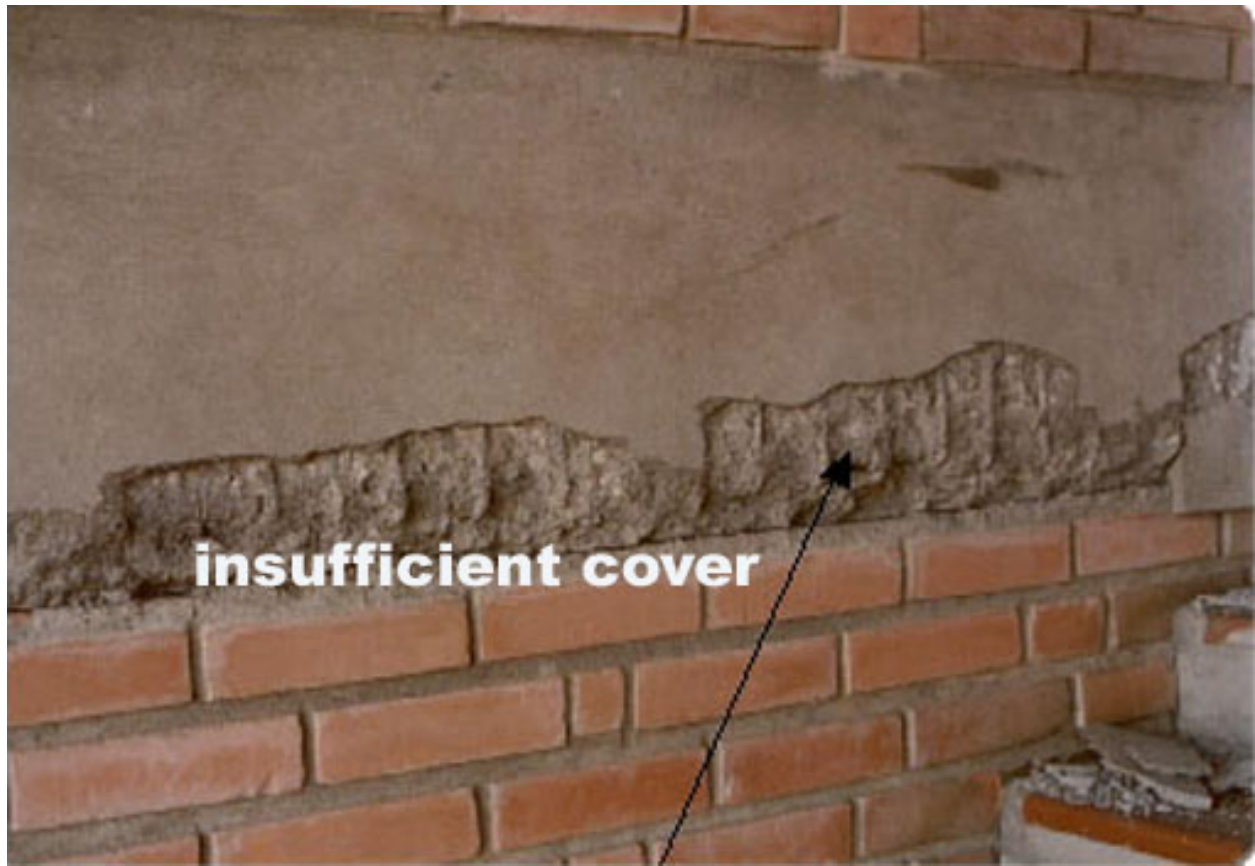
*FIGURE 6K: Earthquake Damage-Inadequate Concrete Cover*

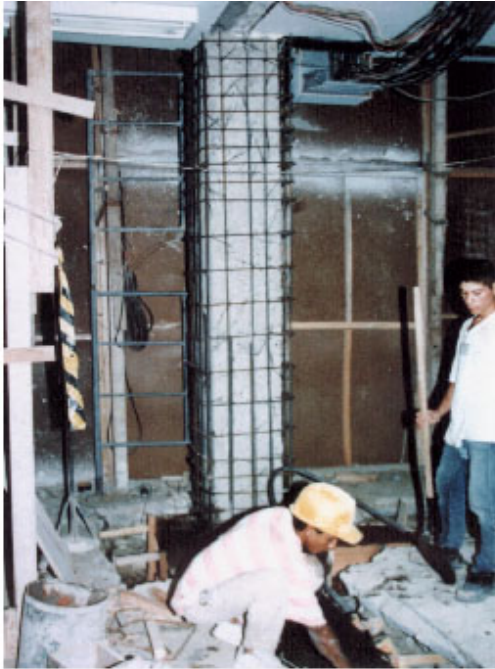
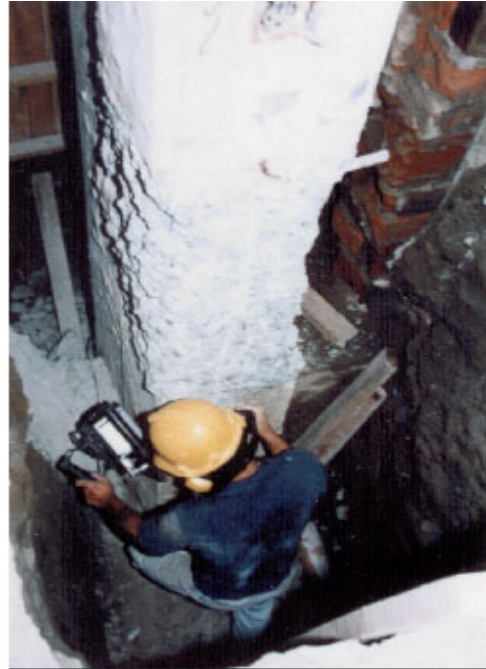
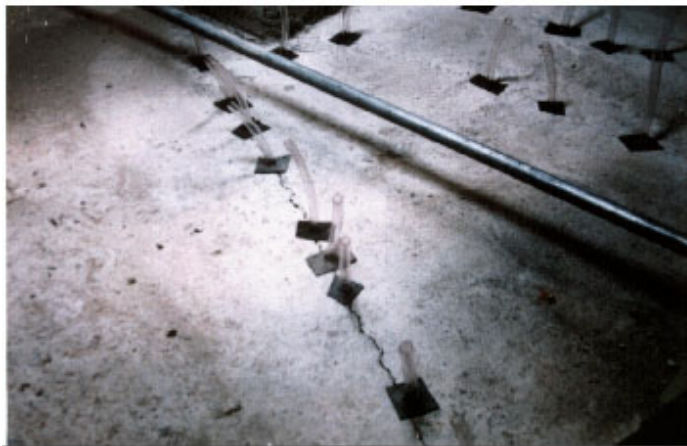
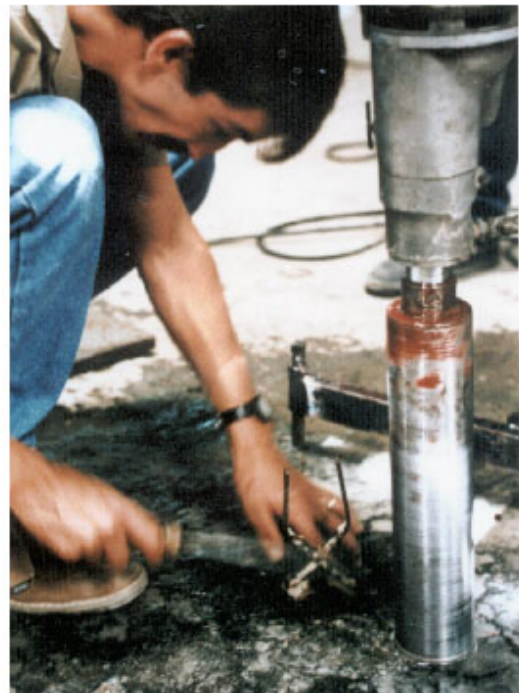
*FIGURE 7D: Seismic Strengthening Techniques - Field Implementation*

New added longitudinal and transversal reinforcement

Anchorage of the new longitudinal reinforcement into the foundation

Epoxy injection of the cracks

Extraction of concrete cores

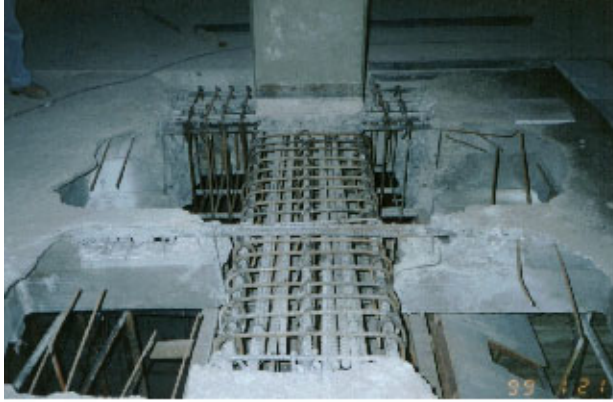
*FIGURE 7E: Seismic Strengthening Techniques - Field Implementation*

In some cases, new stirrups are installed to reinforce a beam-column joint. In this case, the existing concrete in the joint area must be carefully demolished.
