SUMMARY OF THE PROJECT Presented by Luis Gonzalo Mejía C. LGM & Cia Medellín - Colombia

- 1.1 The Distribution Center Las Vegas (Medellín Colombia) is the principal storage and distribution center of the big retail company in Colombia Almacenes Exito S.A. The project has an area of 646.000,0 ft² and was built in year 2005 (Picture 1). On December 24-07, in 4 hours, a conflagration destroyed 430.000,0 ft² of the warehouse (Picture 2). Being centralized the distribution, all activities of the retail company were severely affected and were necessary, after three months of investigations and redesigns, to begin the reconstruction work.

FOTOS REFORZAMIENTO DE PILAS REFORMA CEDI VEGAS

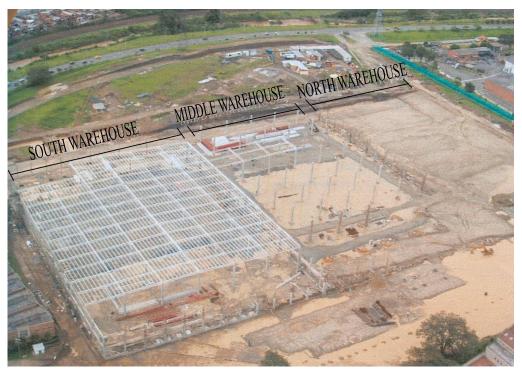
Picture 1 – Distribution Center during the initial construction (Notes: 1. The middle and north warehouses were destroyed by the big fire. 2. For dimensions see figure 1)

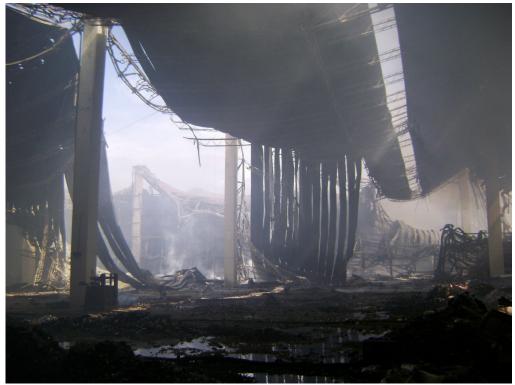
Picture 2 – Warehouse after the fire

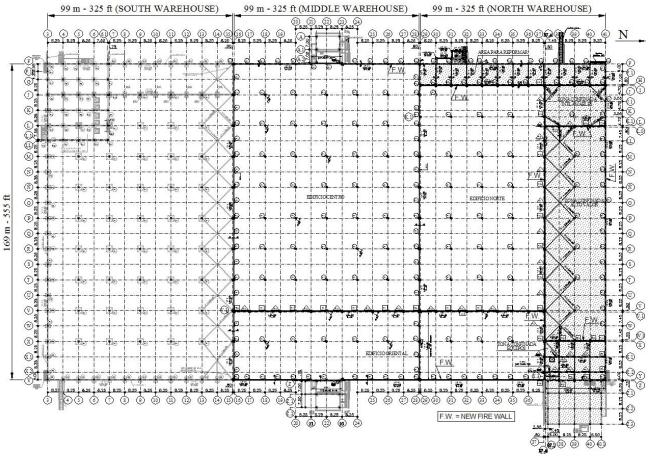
Figure 1 – General Plant
Remark: Dotted areas correspond to mezzanine slabs in level 16.40 ft

- 1.2 The whole building was divided in 3 blocks (Picture 1 and Fig. 1, 2). The dimensions are indicated in the figures. The height of the columns and walls was variable between 33 ft and 46 ft. For the reconstruction was necessary to consider the most severe specifications to protect the new building against fire. So it was necessary to build new fire walls, 40 ft height supported in the old and new frames using the existing deep pier foundations and much of these were unable to resist additional loads. Many of the piers become new loads that were twice the initial loads and for this reason was necessary to strengthen 61 piers (Piers excavated by hand and cast in place). The reconstruction project should be ready for September 2008, also in five months.

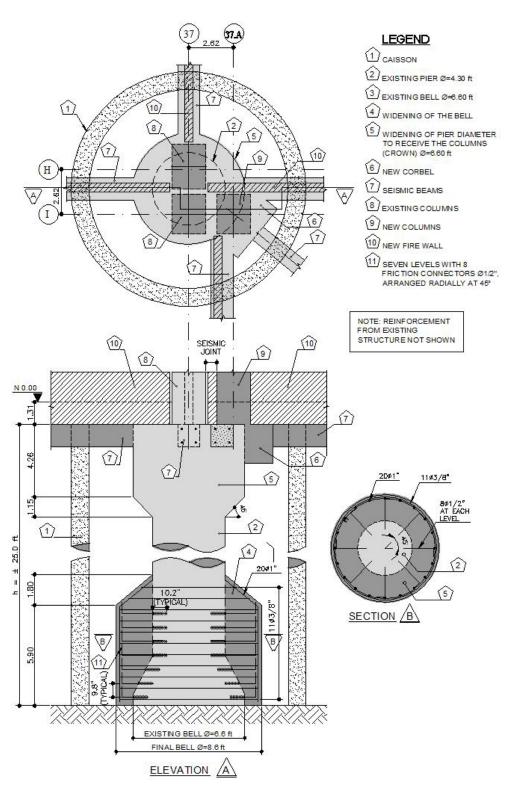
The corbel design was made accordingly the recommendations from Prof. F. Leonhardt.

Detail 1 – Widening of the bell (Plant and elevation)

- 2.1 Due to the new loads it was necessary to increase the bell diameter. To become this objective a caisson was built, nevertheless because the manual labor it isn't expensive, which such a diameter that allow the worker to increase the bell diameter to the required dimension (Pictures 3, 4, 5 and structural detail 1).
- 2.2 The new columns were founded in corbels that were anchored in the top of the pier (Pictures 6, 7 and 8 and structural details 2 y 3). Sometimes were necessary to use two corbels per pier (pictures 9 and 10 and structural detail 3).
- 2.3 With this design, the work was done, not only timely but two months early.
