# PROTECT2015

**The Fifth International Workshop on Performance, Protection,  
and Strengthening of Structures under Extreme Loading**

Strengthening and Repair of Las Vegas Distribution Center after a severe fire

By Luis Gonzalo Mejía C. P.E. MSc

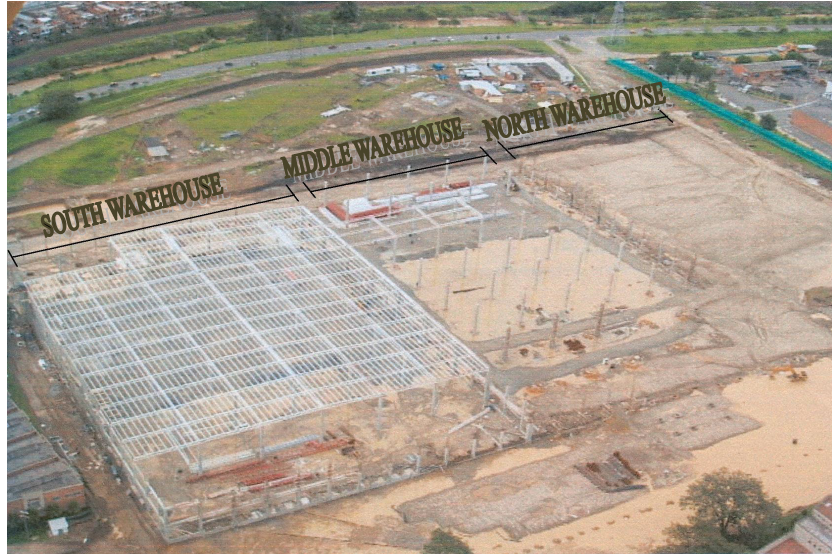
The Distribution Center Las Vegas (Medellin – Colombia) is the principal storage and distribution center of the big retail company in Colombia. The project has an area of 646.000,0 ft<sup>2</sup> and was built in year 2005 (Figure 1). Some years ago, in 4 hours, a conflagration destroyed 430.000,0 ft<sup>2</sup> of the warehouse (Figure 2). Being centralized the distribution; all activities of the retail company were severely affected and were necessary, after three months of investigations and redesigns, to begin the reconstruction work.

Figure 1. Distribution Center during the initial construction (Notes: 1. the middle and north warehouses were destroyed by the big fire. 2. For dimensions see figures 3, 4)

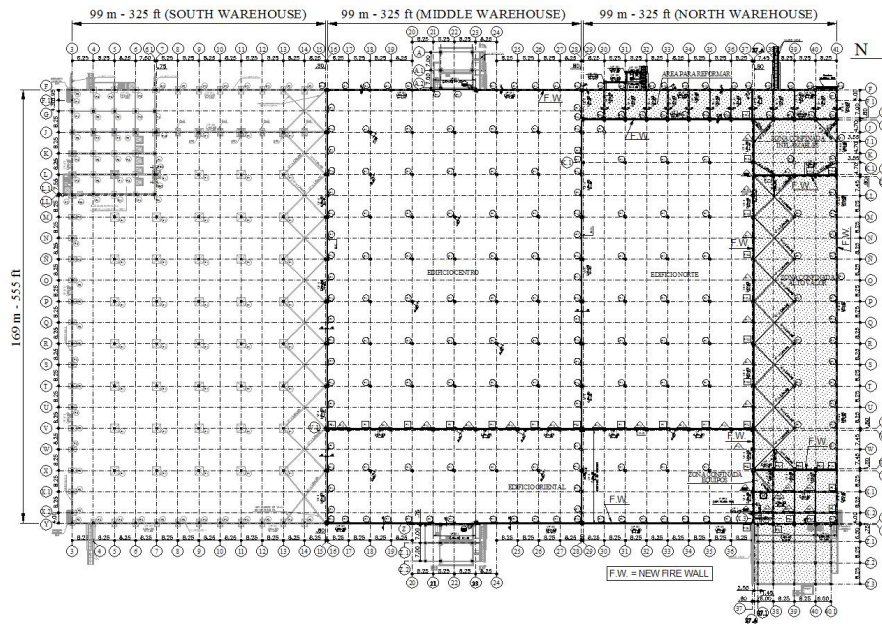
Figure 3. General Plant

The whole building was divided in 3 blocks (Figure 1 and Figures 3 and 4). The dimensions are indicated in the figures. The height of the columns and walls was variable between 33 ft and 46 ft. For the reconstruction was necessary to consider the most severe specifications to protect the new building against fire. So it was necessary to build new fire walls, 40 ft height supported in the old and new additional frames using the existing deep pier foundations and much of these were unable to resist additional loads. Many of the piers become new loads that were twice the initial loads and for this reason were necessary to strengthen 61 piers (Piers excavated by hand and cast in place).

Remark: Dotted areas correspond to mezzanine slabs in level 16.40 ft
