# World Housing Encyclopedia Report

Country: Colombia

Housing Type: Clay brick/concrete block masonry walls with concrete floors (predating seismic codes or with a few seismic features)

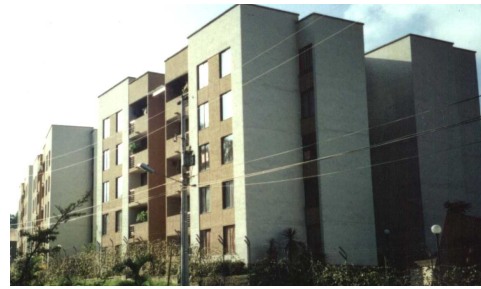
FIGURE 1: Typical Building

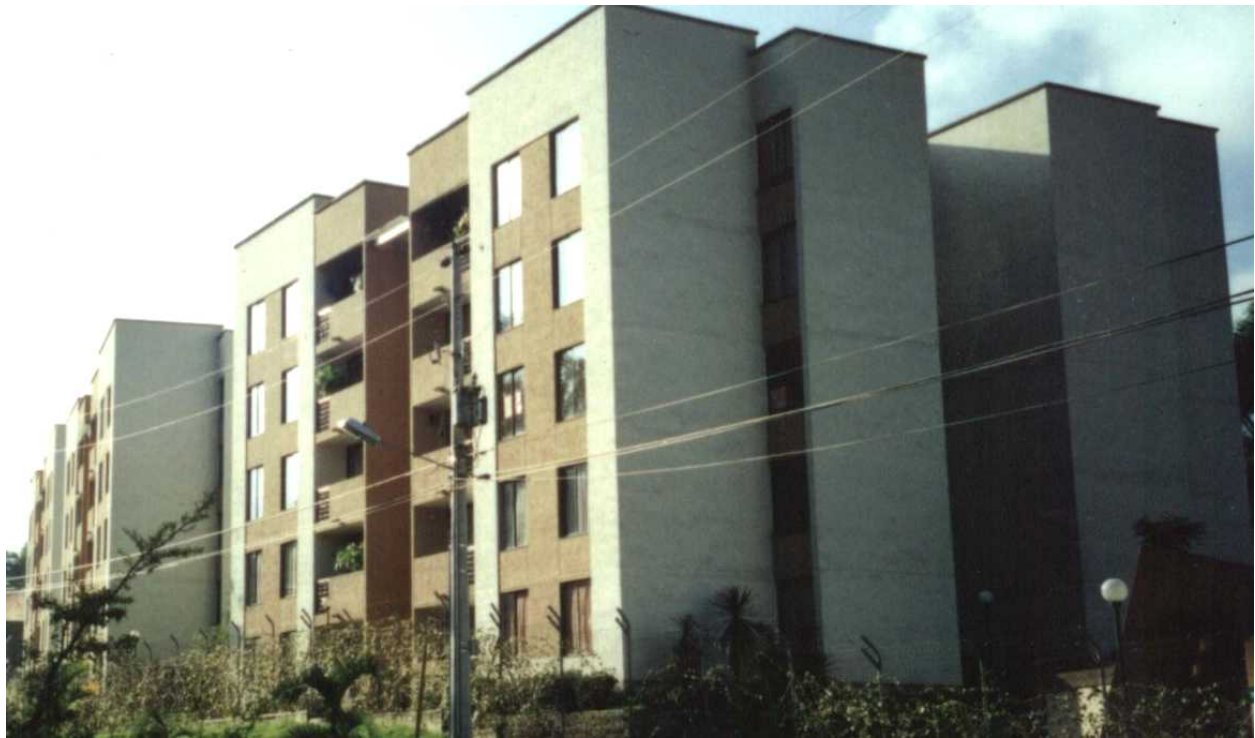
FIGURE 1: Typical Building

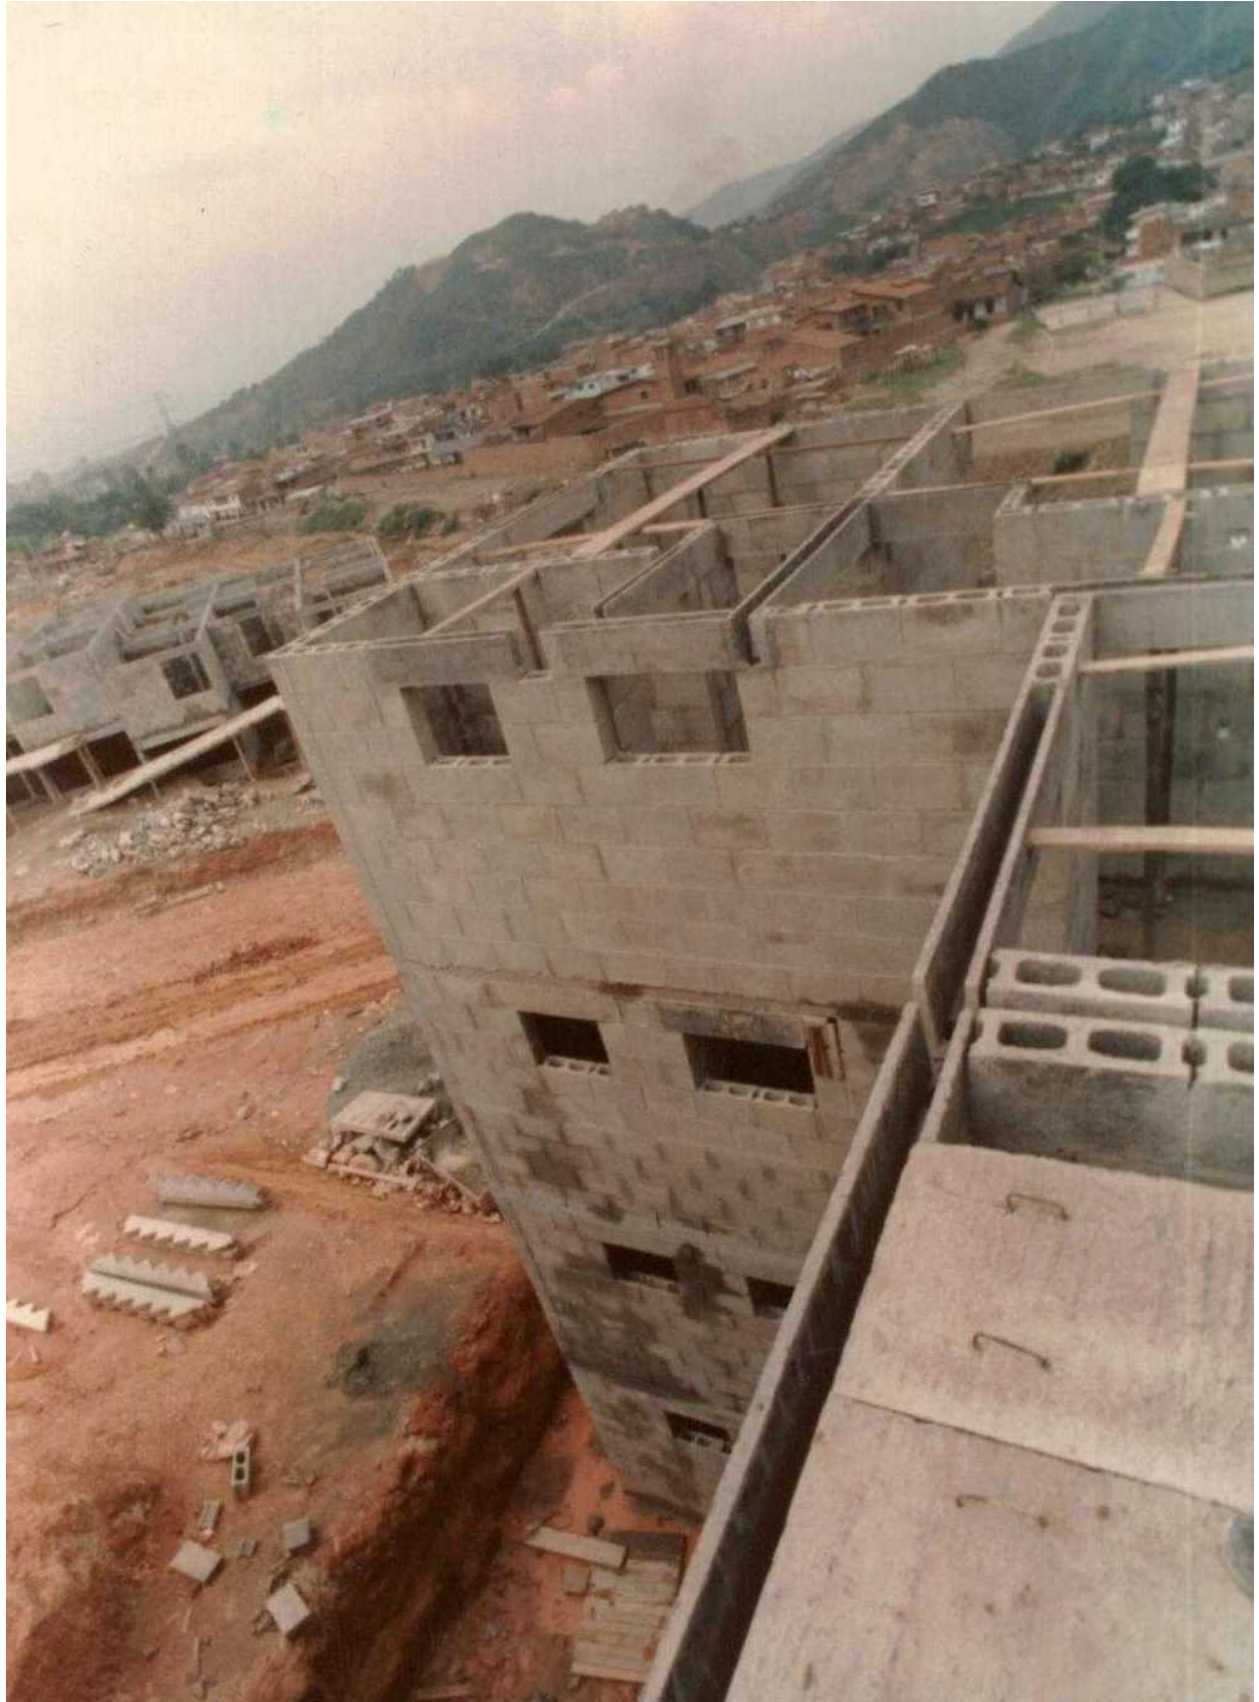
*FIGURE 4B: Critical Structural Details - Modern buildings Built with Continuous R/C Bond Beams.*

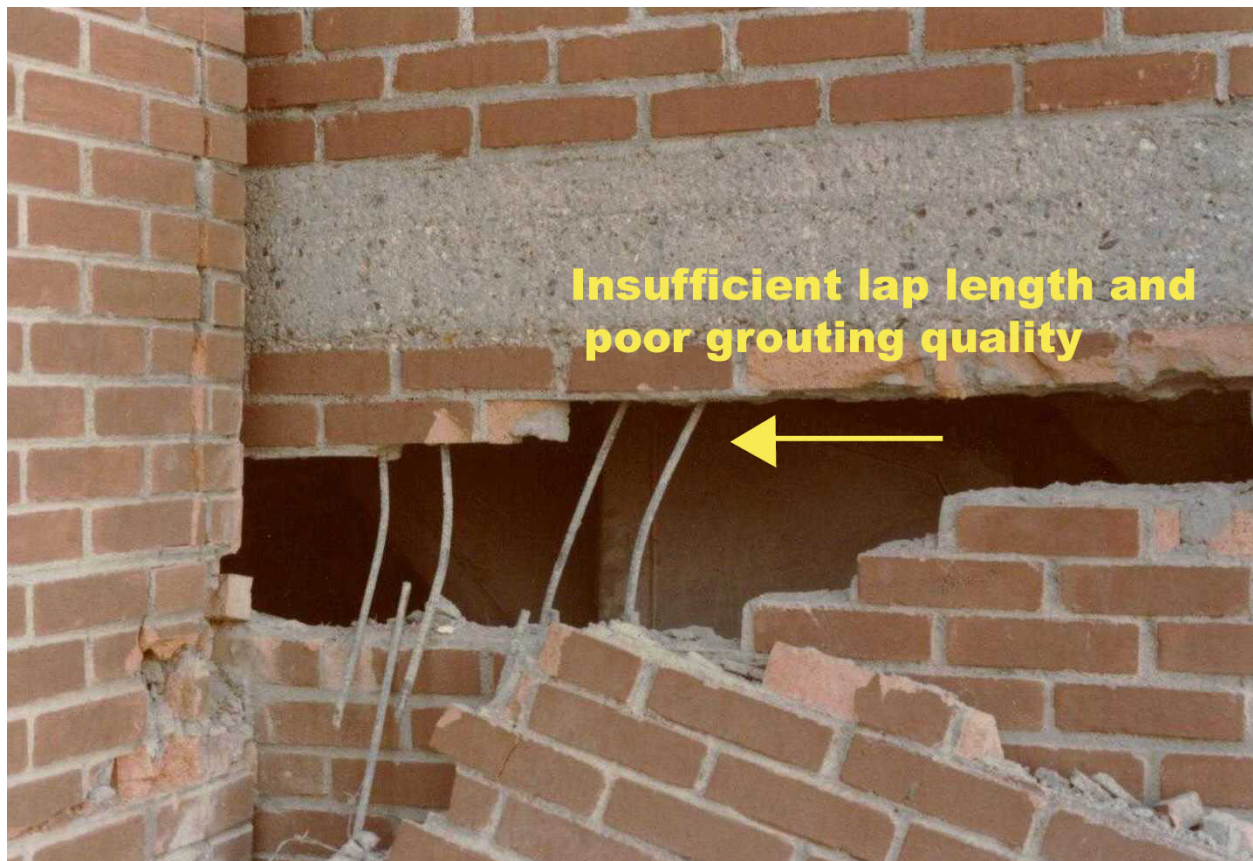
*FIGURE 5A: Key Seismic Deficiencies - Inadequate Reinforcement and Poor Grouting (note the reinforcement bar slippage)*

**Additional Comments:** For the illustration of seismic deficiencies please see Figures 5A, 5B, 5C, 5D, 5E, 5F, 5G, and 5H.

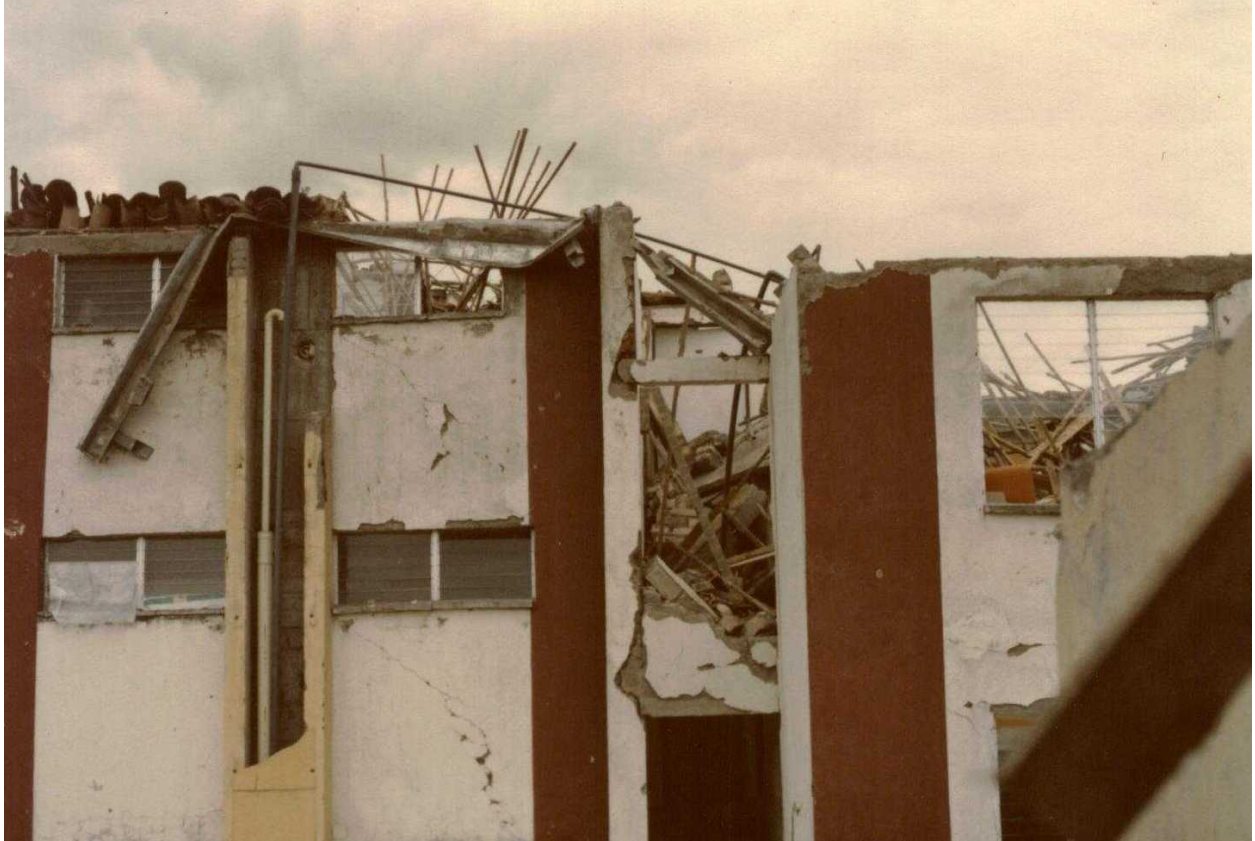
*FIGURE 5B: Seismic Deficiencies - Discontinuous R/C Bond Beams.*

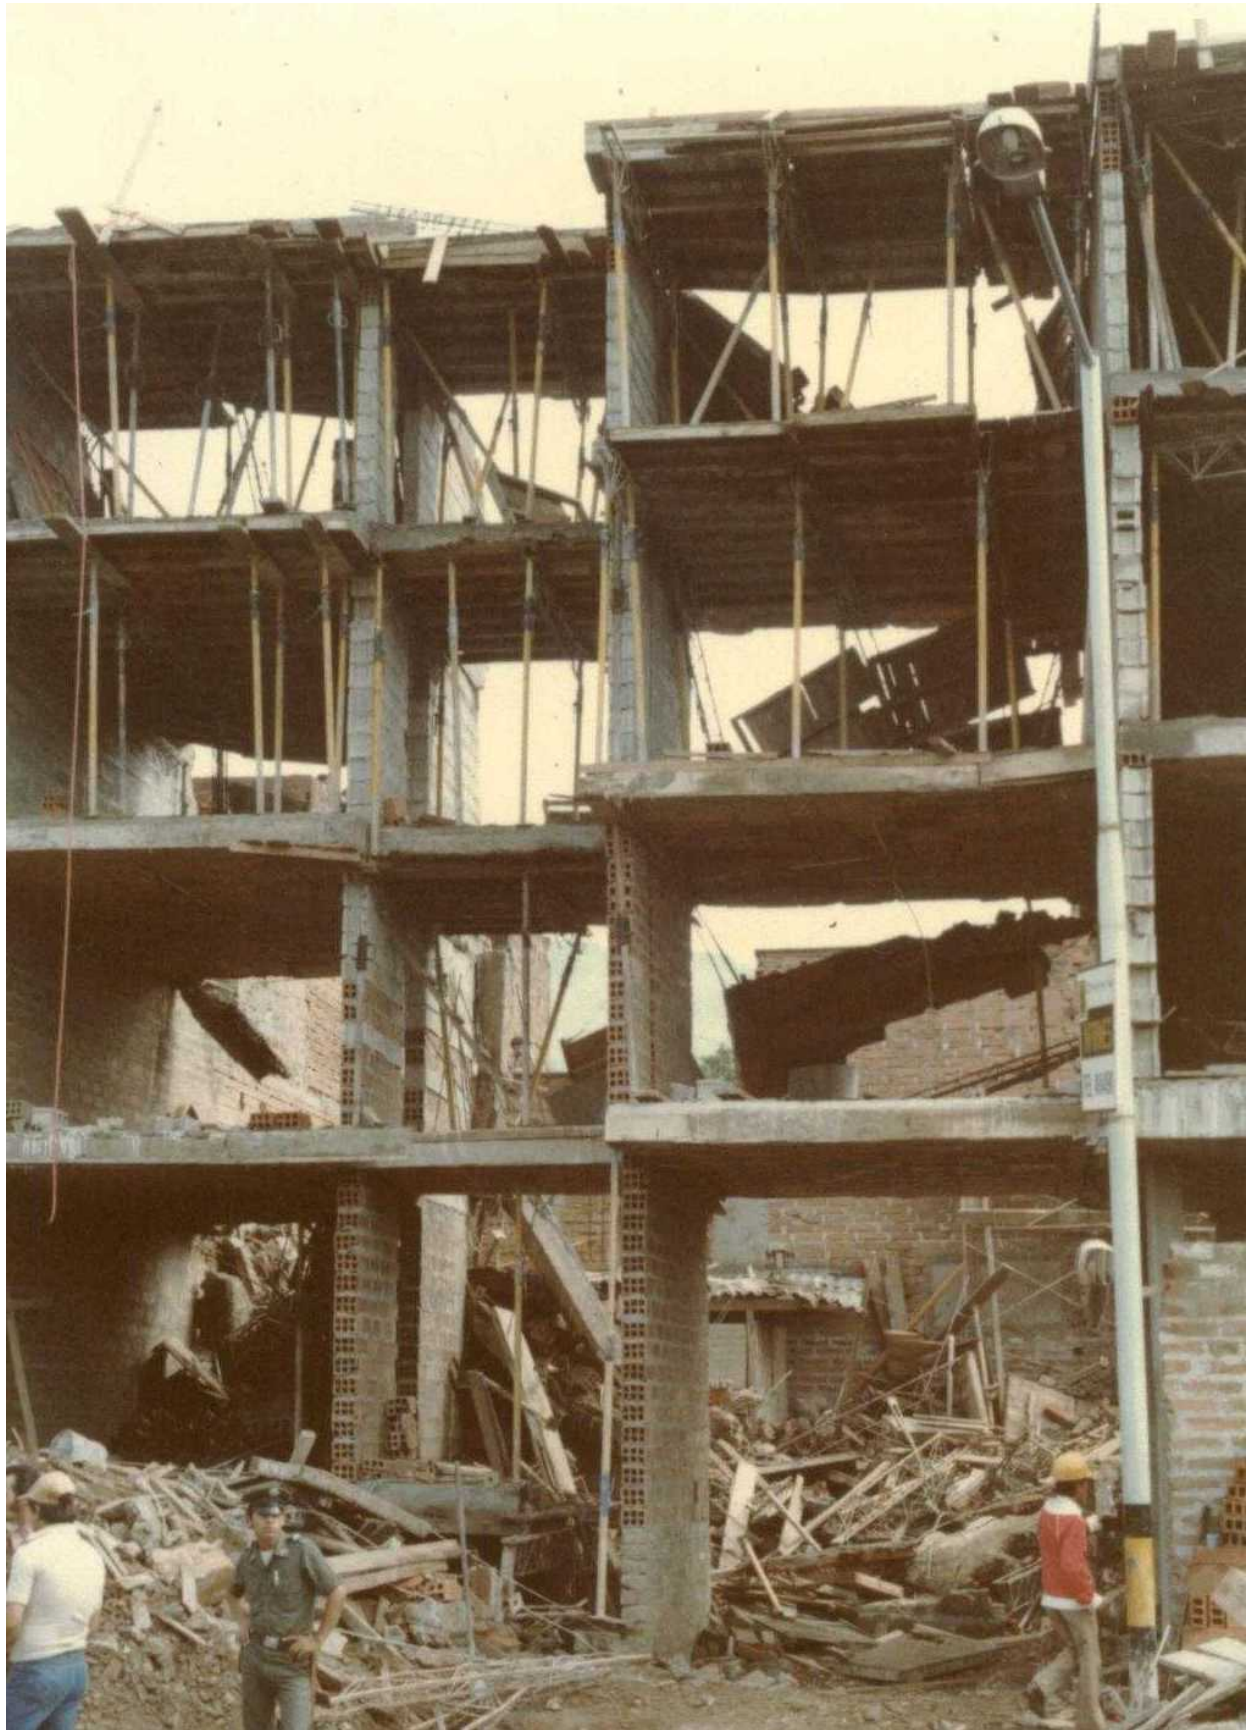
*FIGURE 5C: Poor construction practice - unreinforced masonry walls and the absence of cross walls  
(note that both clay bricks and concrete blocks were used for the wall construction).*

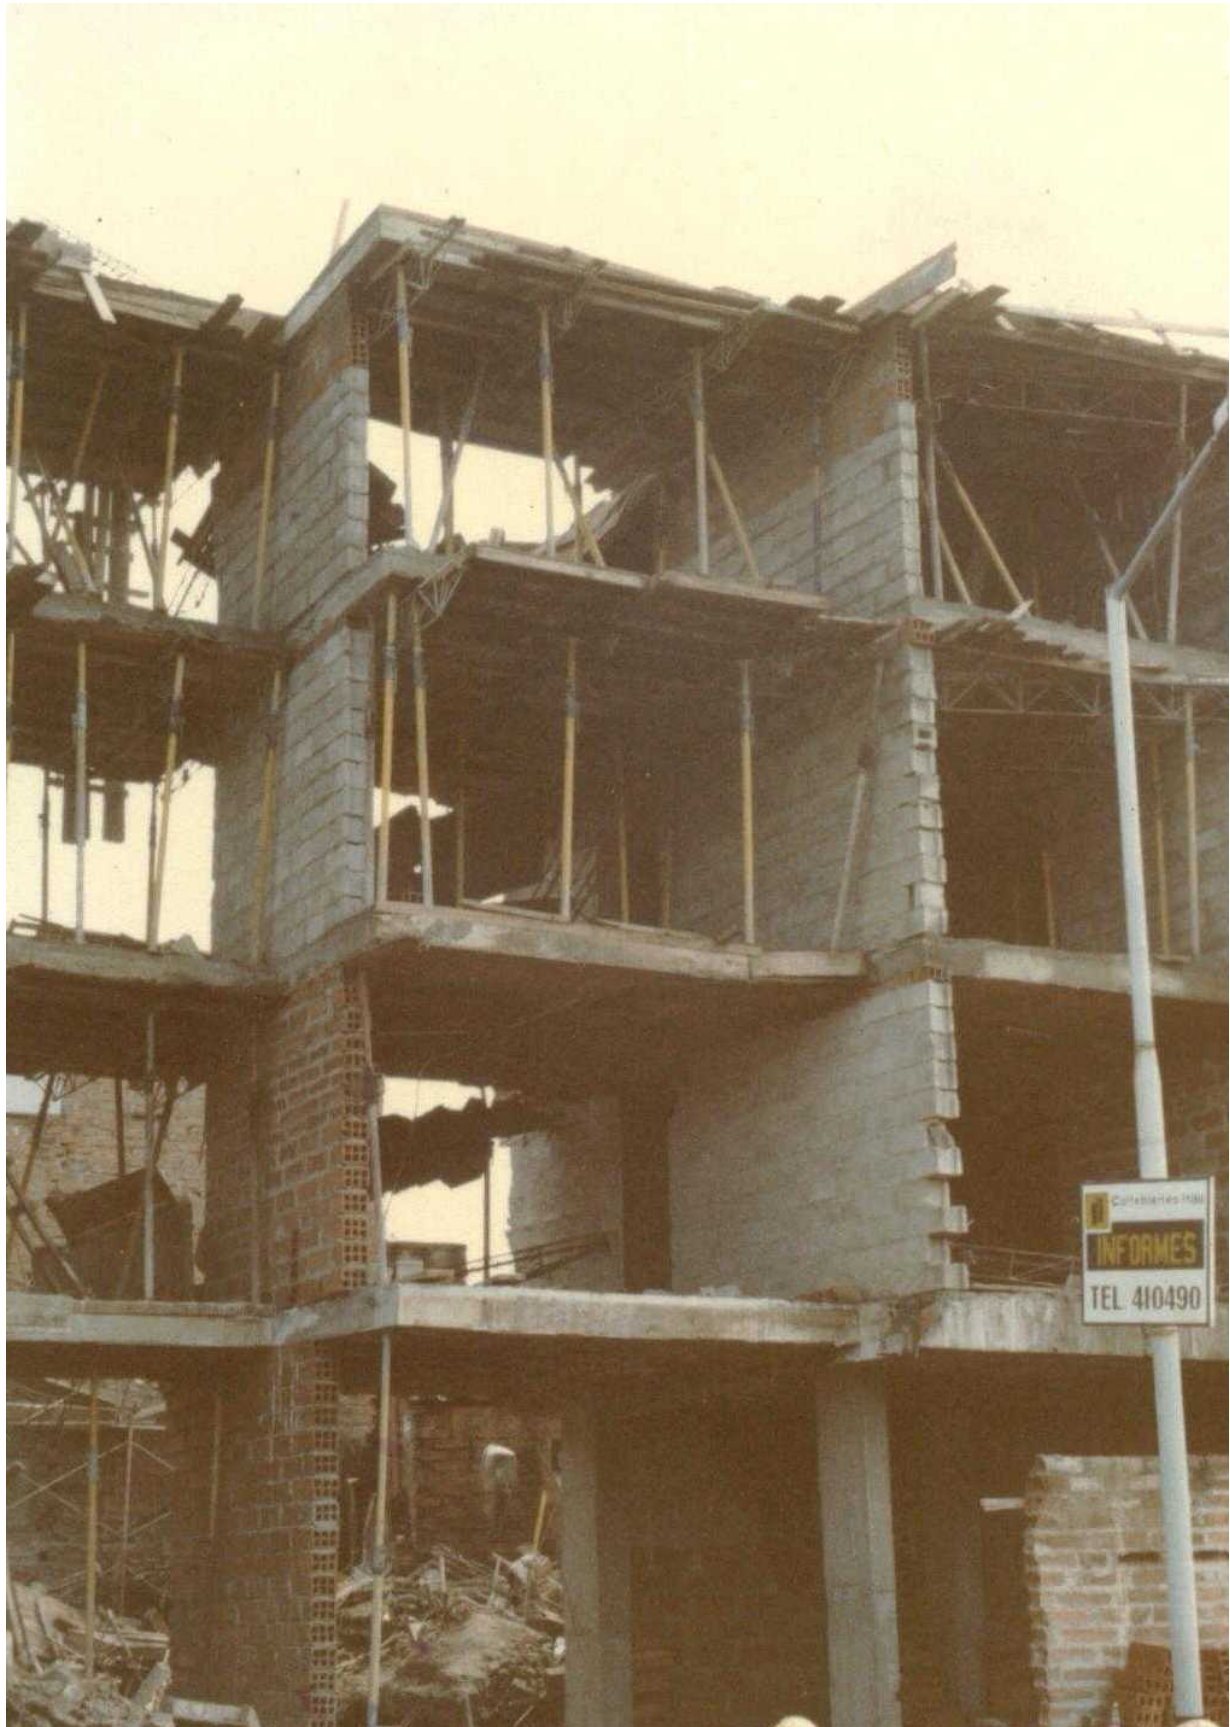
*FIGURE 5D: Vertical Stiffness Discontinuity - Walls Interrupted at the First Story and Replaced with Columns.*

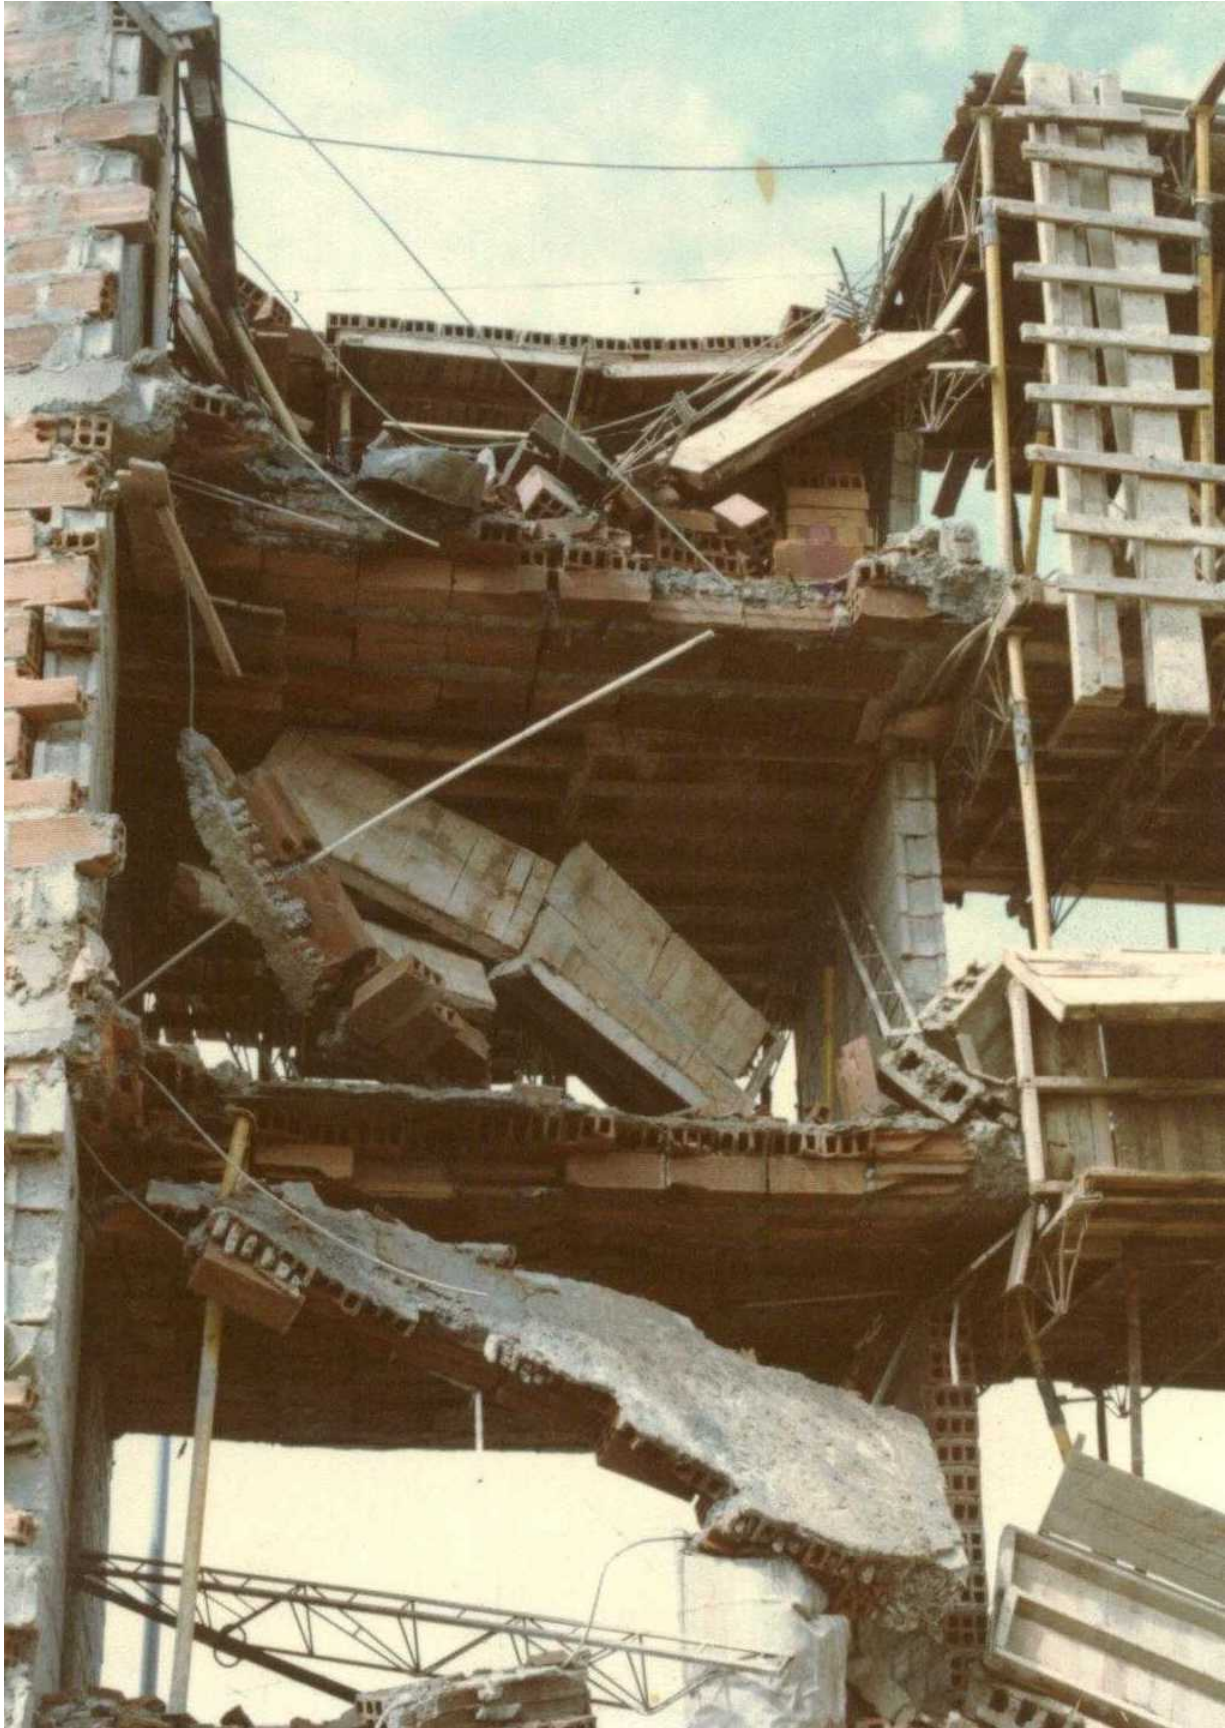
*FIGURE 5E: Seismic Deficiencies - An Example of a Building Collapse Caused by Gravity Loads Only (buildings with such weaknesses have very little chance to survive earthquake effects).*

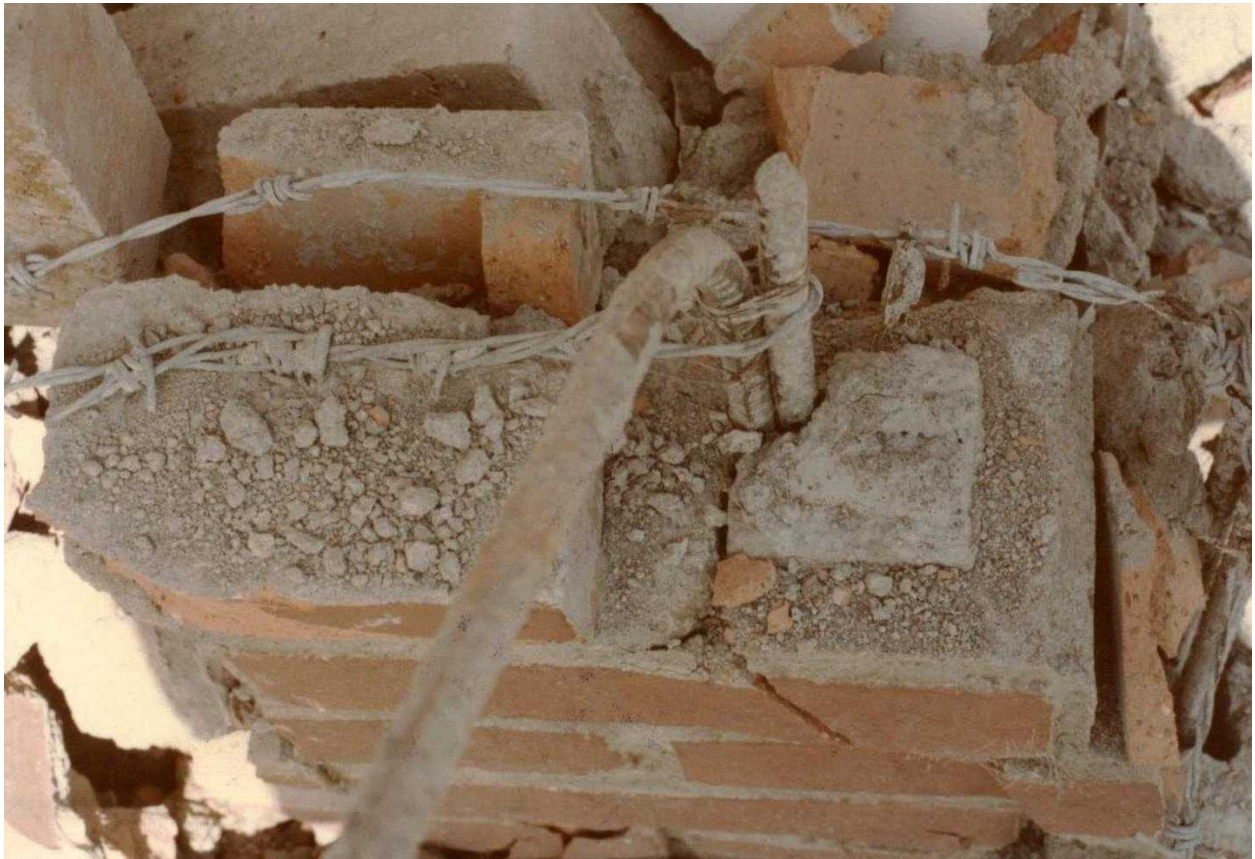
*FIGURE 5F: Seismic Deficiencies - Poor Quality of Materials (mortar and grout); Inadequate Vertical and Horizontal Reinforcement.*

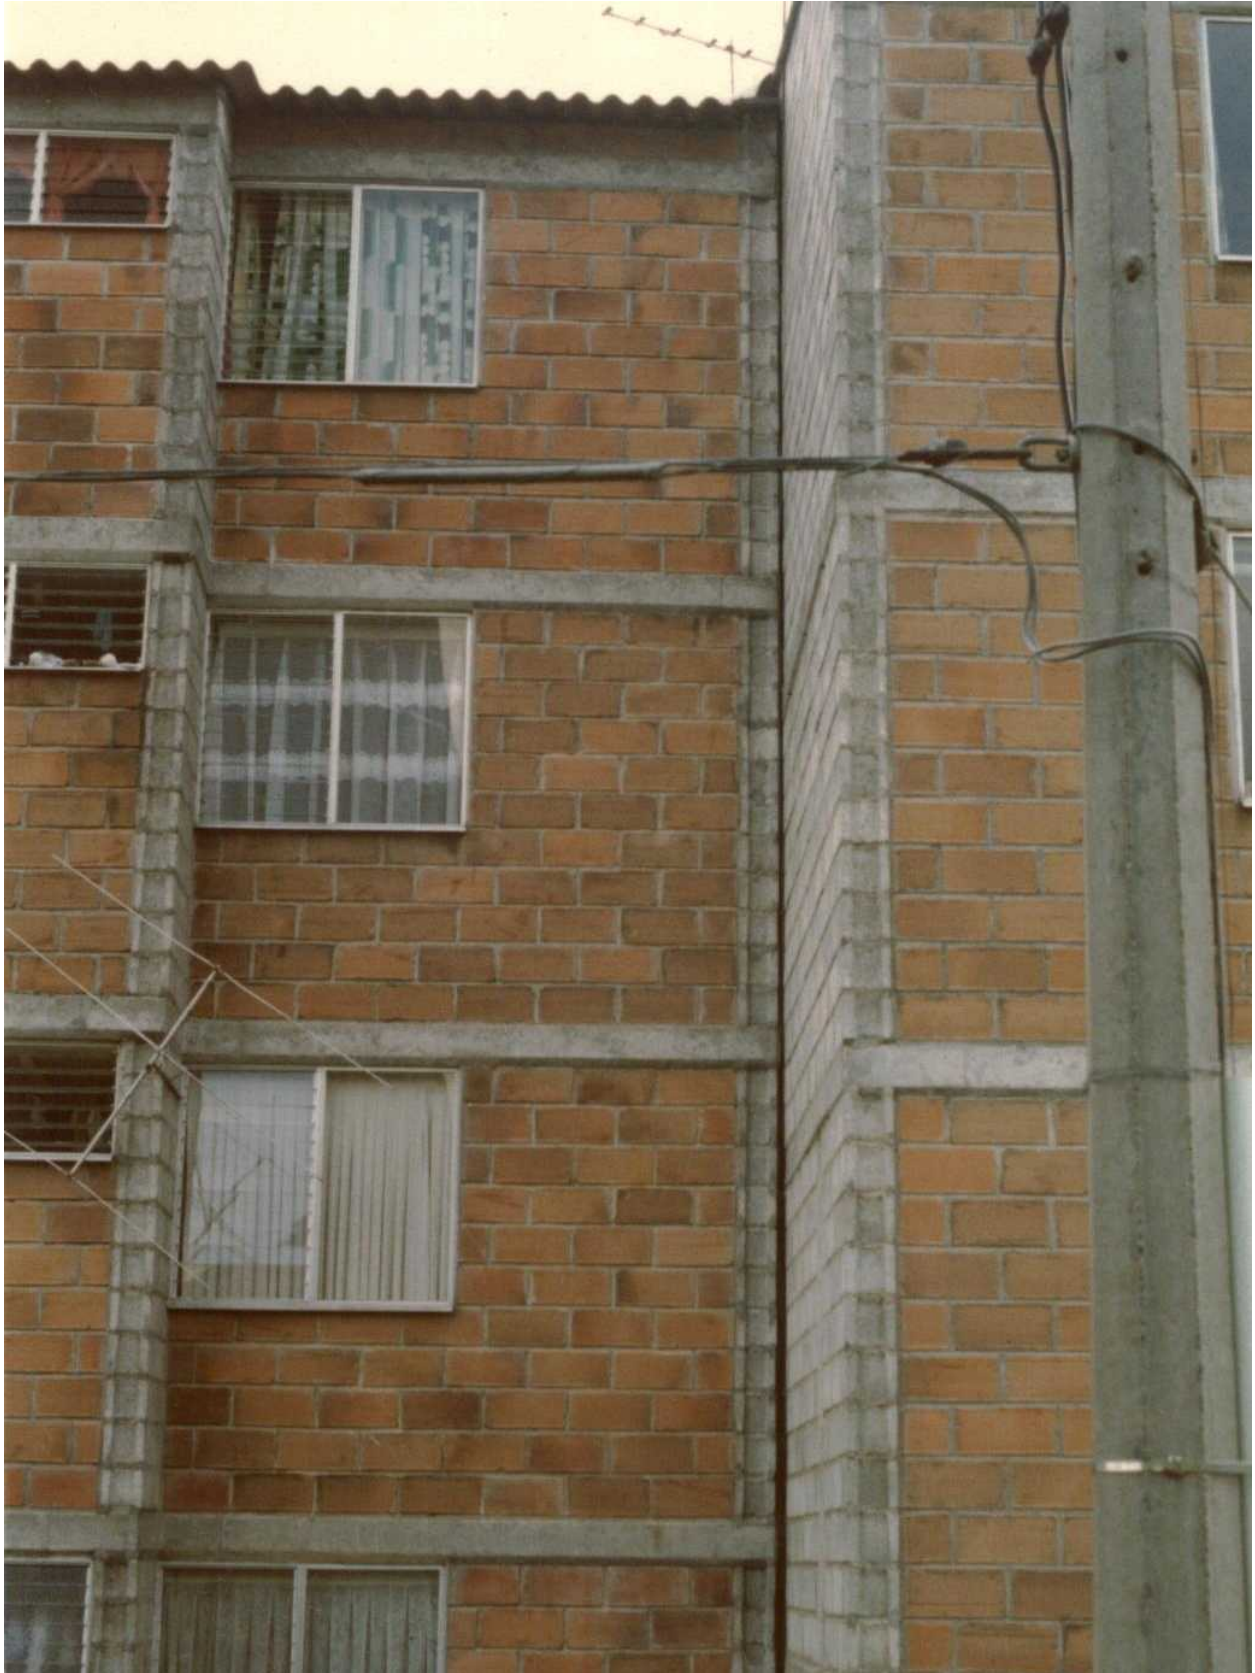
*FIGURE 5G: A building weakened due to tilting induced by a pre-earthquake foundation settlement*

*(separation between the two buildings was 100 mm at ground level but 0 mm at the top). Such buildings are likely to suffer more extensive earthquake damage.*

**Additional Comments:** Foundation Performance: Occasionally, there are buildings with induced weaknesses caused by foundation movements (please see Figure 5G and 5H). Wall-Roof connections: See Additional Comments in Section 4.5 "Type of floor/roof system".

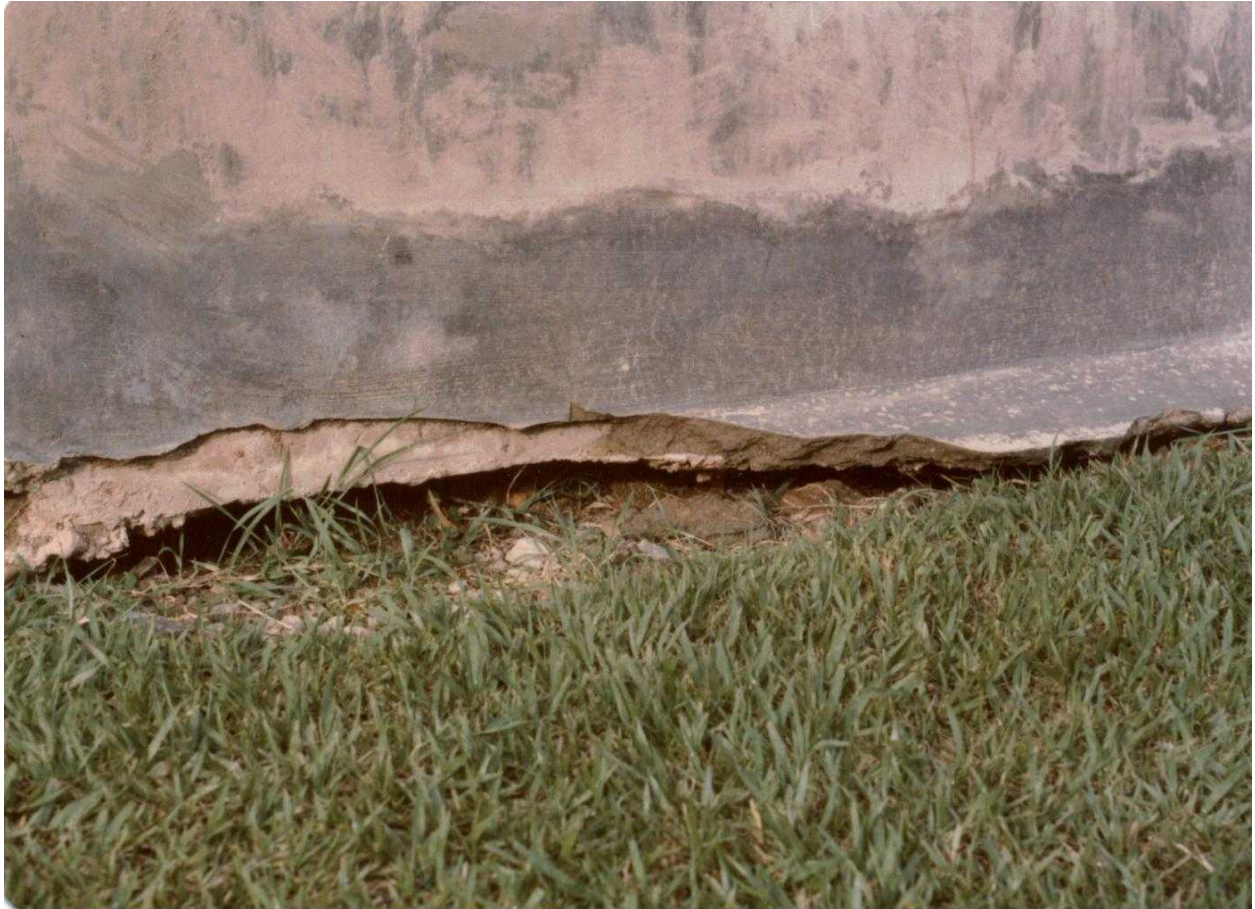
*FIGURE 5H: A building weakened due to tilting induced by a pre-earthquake foundation settlement (separation between the two buildings was 100 mm at ground level but 0 mm at the top). Such buildings are likely to suffer more extensive earthquake damage.*

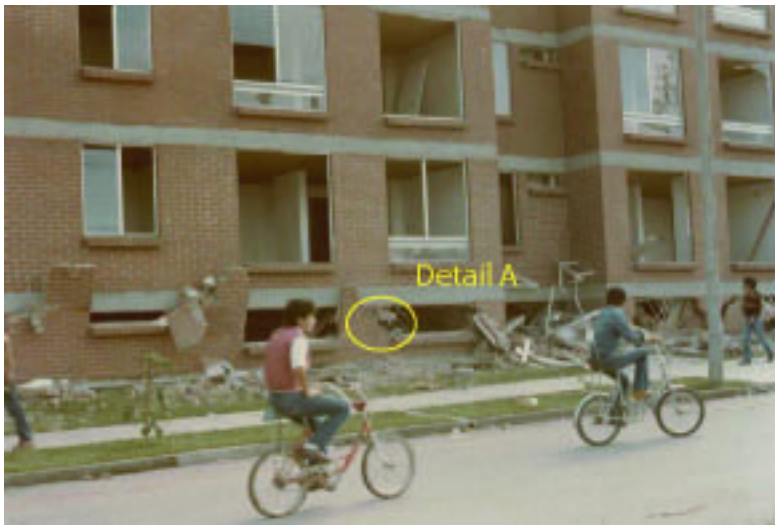
*FIGURE 6A: Typical Earthquake Damage- Failure of Load bearing Masonry Walls*

*Additional Comments:* Typical earthquake damages are illustrated in Figures 6A, 6B, 6C, 6D, 6E, 6F, 6G, 6H, and 6I.

As the amount of reinforcement is it rather limited (and in some cases does not exist at all), and the quality of materials and workmanship is generally poor, this construction type is very susceptible to earthquake effects, as illustrated in Figures 6A, 6B, 6C, 6D, 6E, 6F, 6G, 6H and 6I).

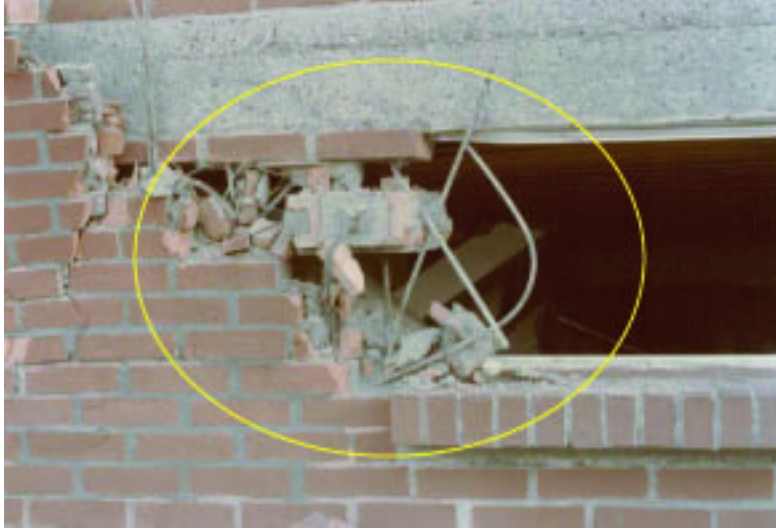
*FIGURE 6B: Typical Earthquake Damage - Inadequate Reinforcement (Detail A shown on Figure 6)*

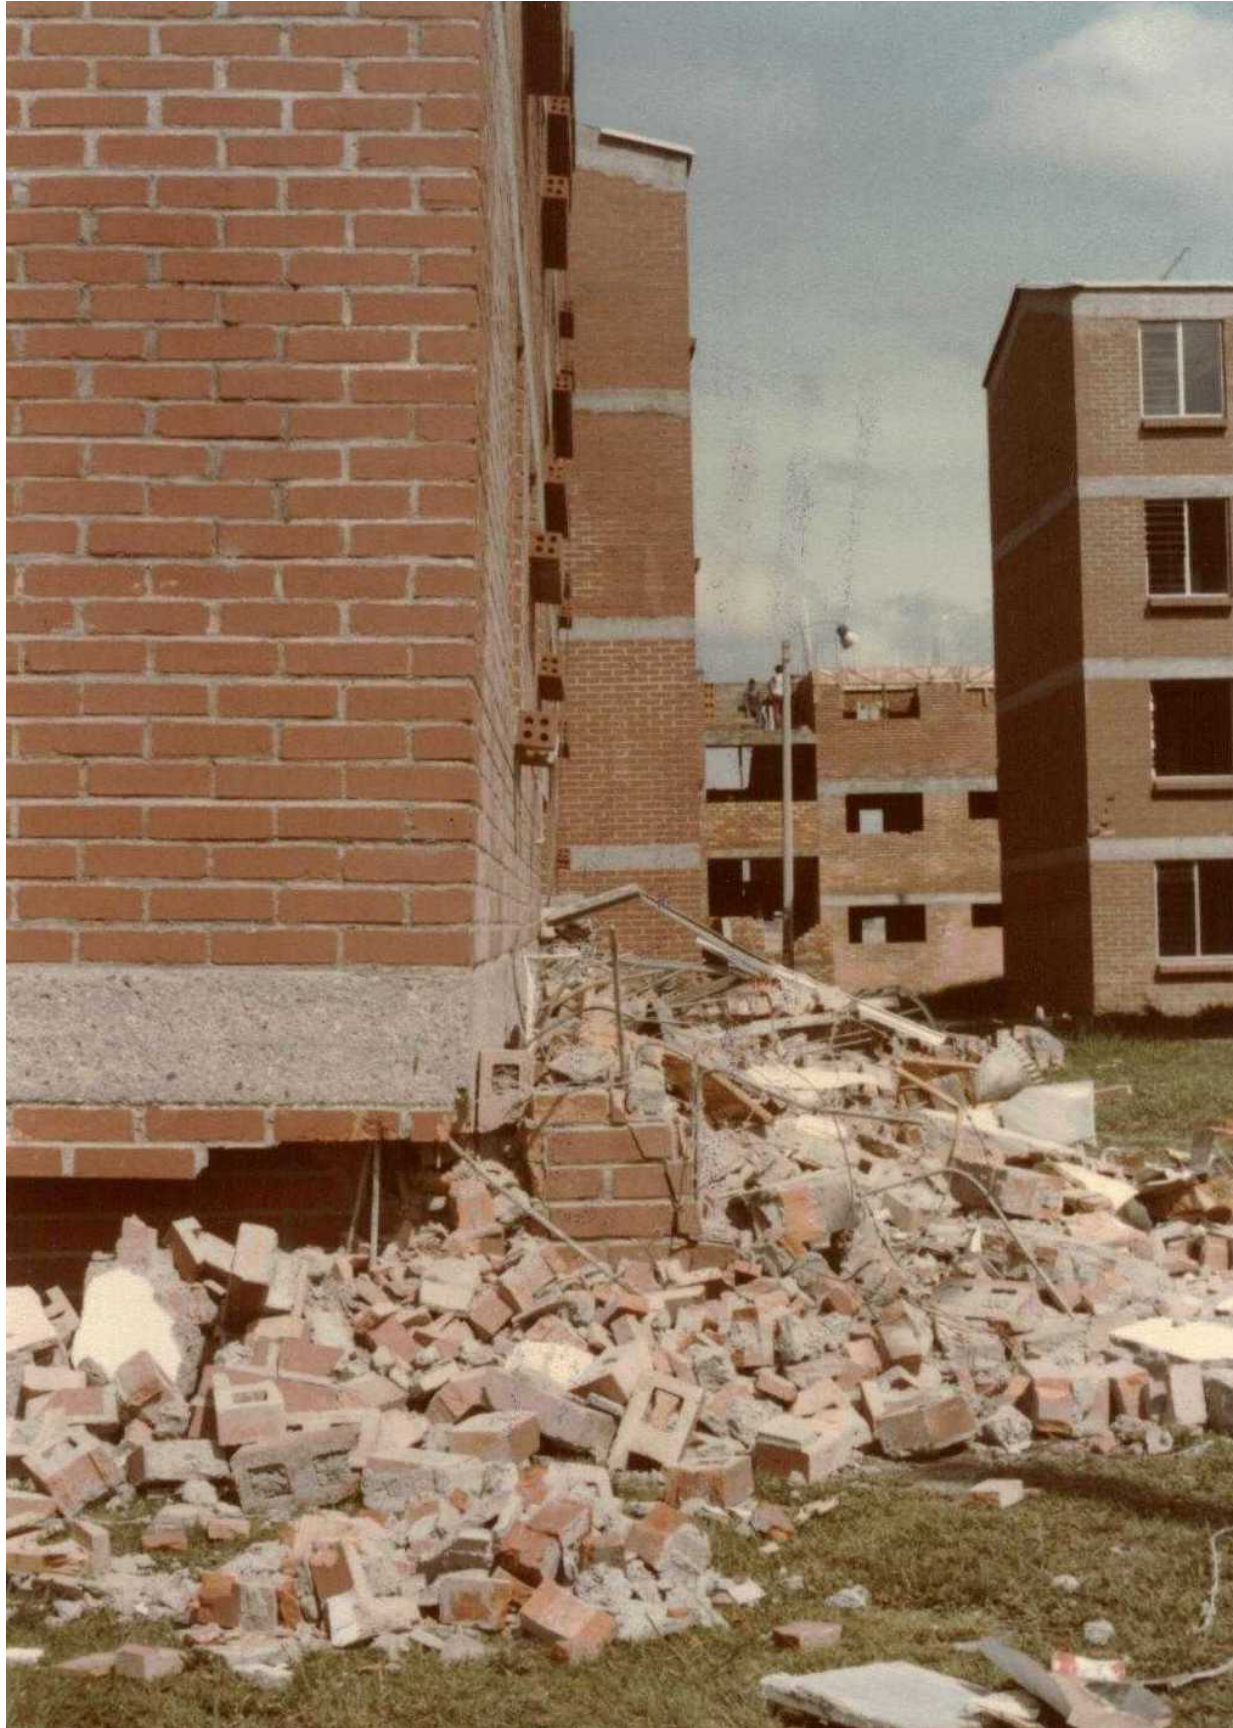
*FIGURE 6C: Typical Earthquake Damage- Lateral Movement of the Collapsed Building Relative to the Foundations*

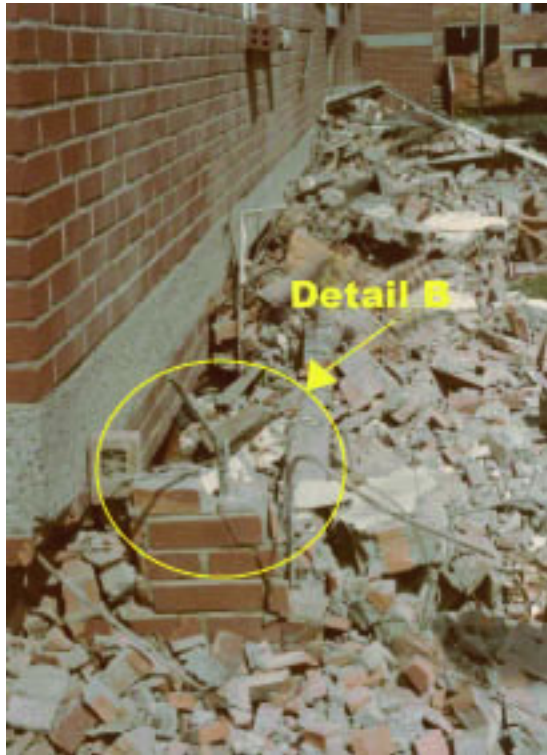
*FIGURE 6D: Typical Earthquake Damage - Detail B Shown on Figure 6b*

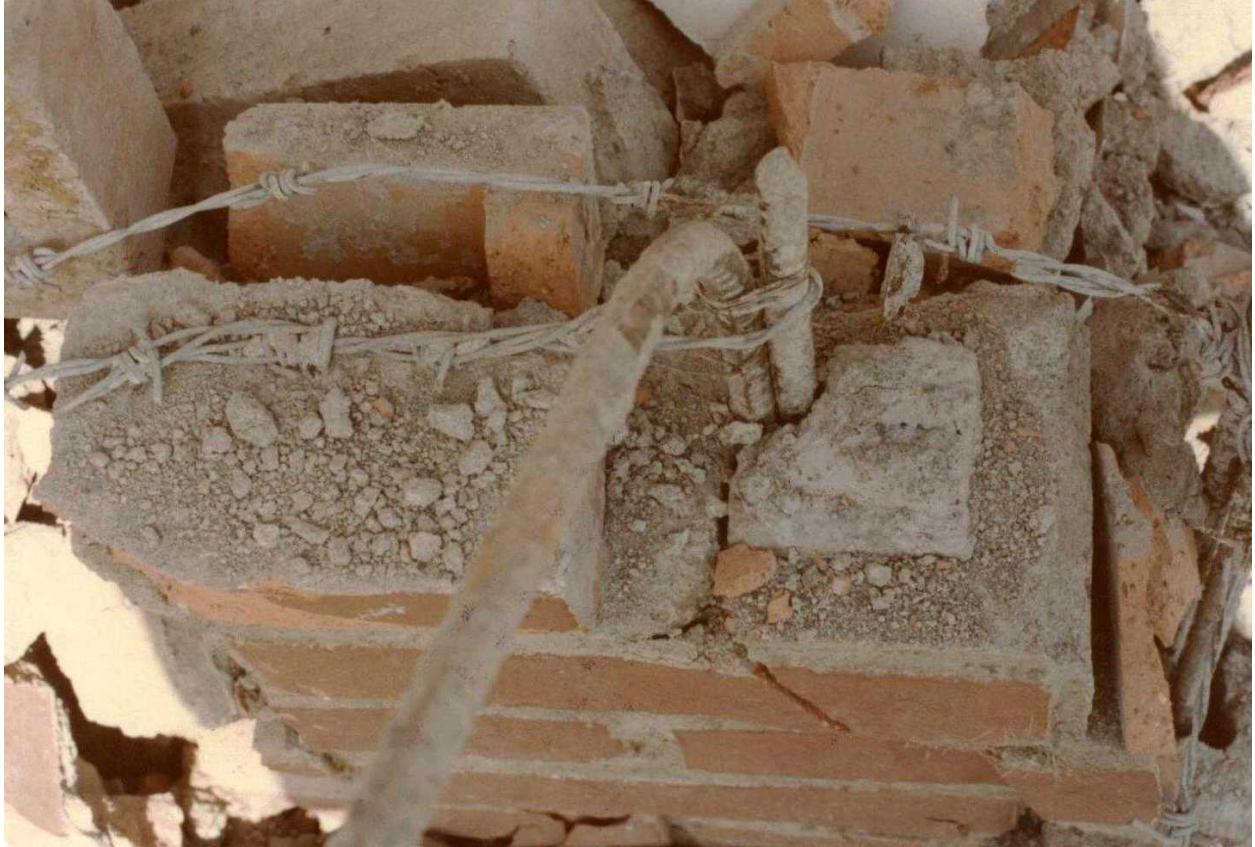
*FIGURE 6E: Typical Earthquake Damage - Poor Workmanship and Inadequate Reinforcement (this is an enlarged detail B shown of Figure 6c)*
