# World Housing Encyclopedia Report

Country: Colombia

Housing Type: Clay brick/concrete block masonry walls with concrete floors (predating seismic codes or with a few seismic features)

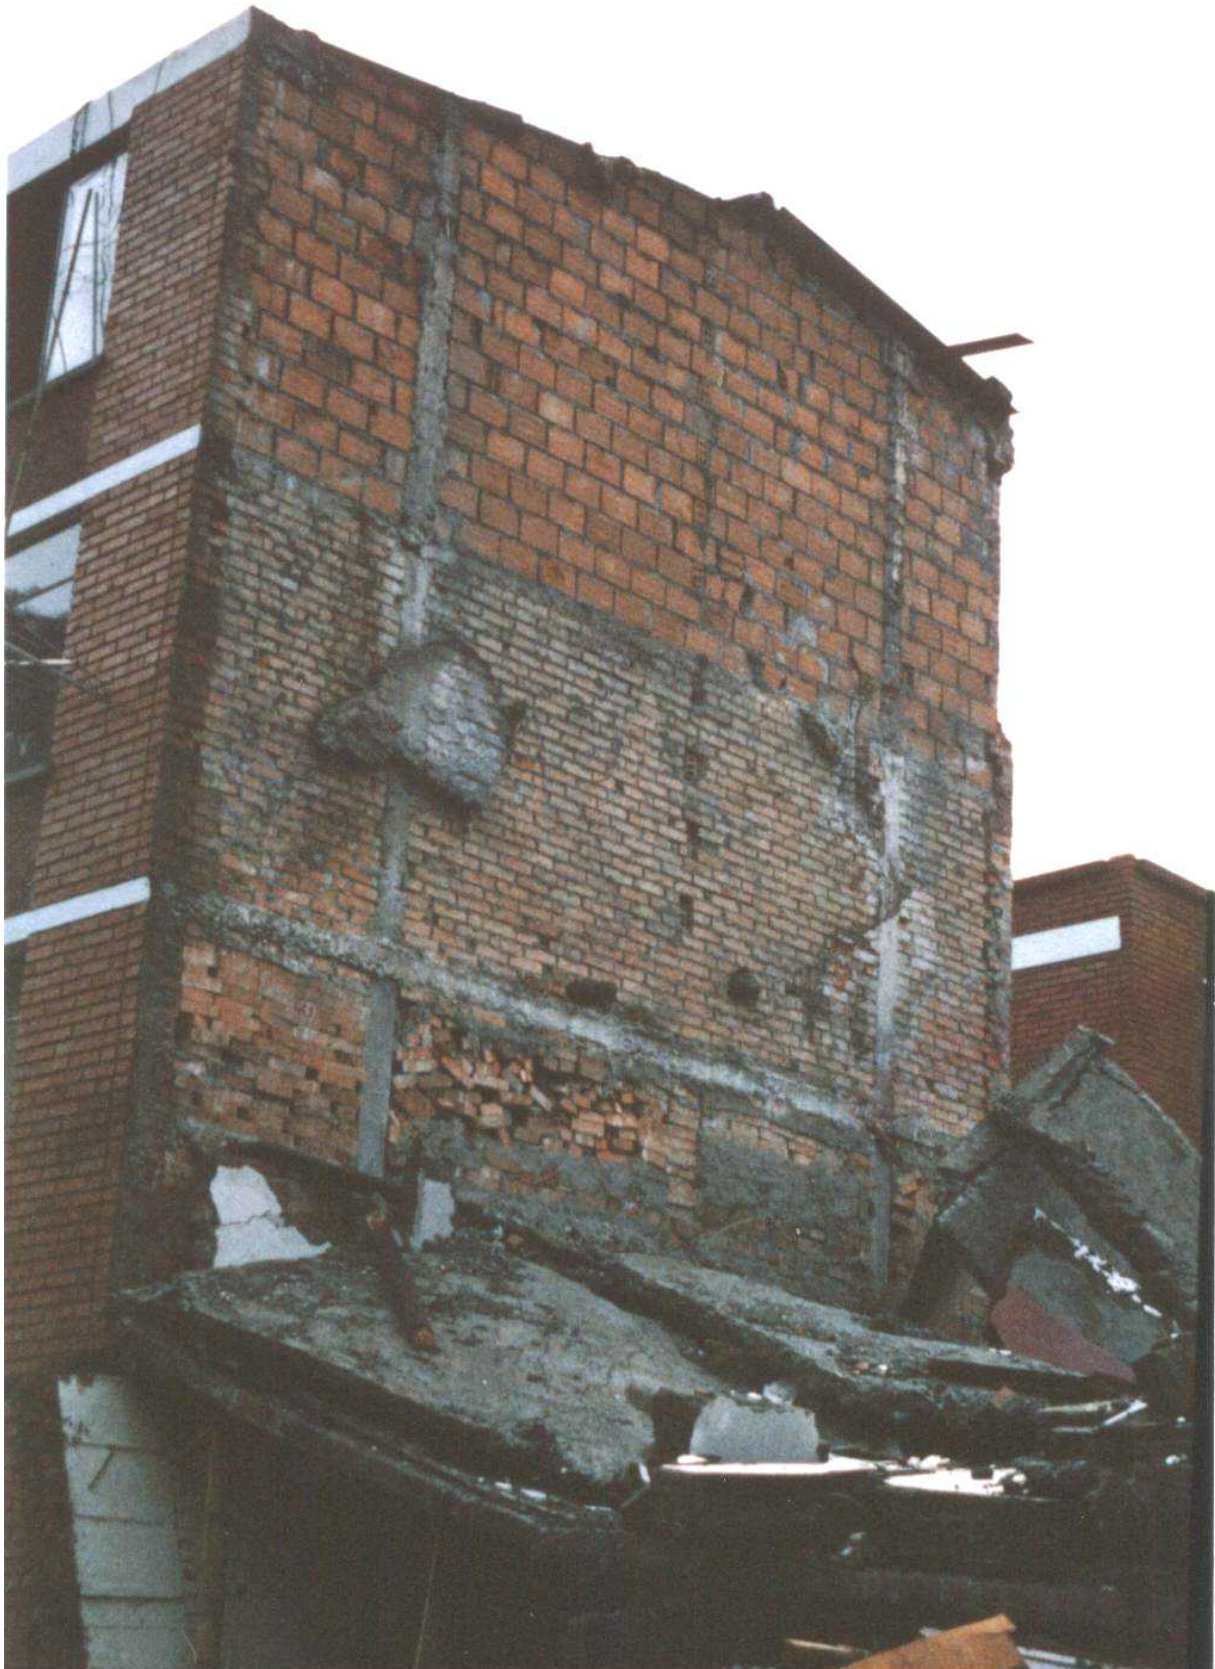
*FIGURE 6F: Typical Earthquake Damage Illustrating Two Similar Confined Masonry Buildings (note that the building on the right-hand side collapsed while the one on the left remained standing)*

*Additional Comments:* Typical earthquake damages are illustrated in Figures 6A, 6B, 6C, 6D, 6E, 6F, 6G, 6H, and 6I.

As the amount of reinforcement is it rather limited (and in some cases does not exist at all), and the quality of materials and workmanship is generally poor, this construction type is very susceptible to earthquake effects, as illustrated in Figures 6A, 6B, 6C, 6D, 6E, 6F, 6G, 6H and 6I).

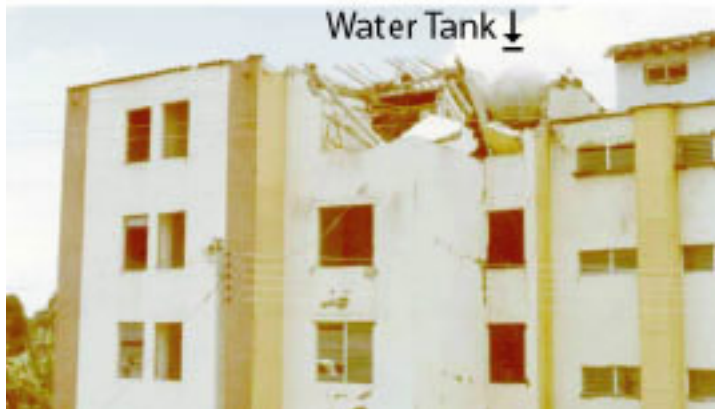
*FIGURE 6G: Typical Earthquake Damage- Collapsed Roof; note the absence of continuous RC bond beam and the wall-roof connection; the water tank at the roof "walked off" and had contributed to the roof collapse.*

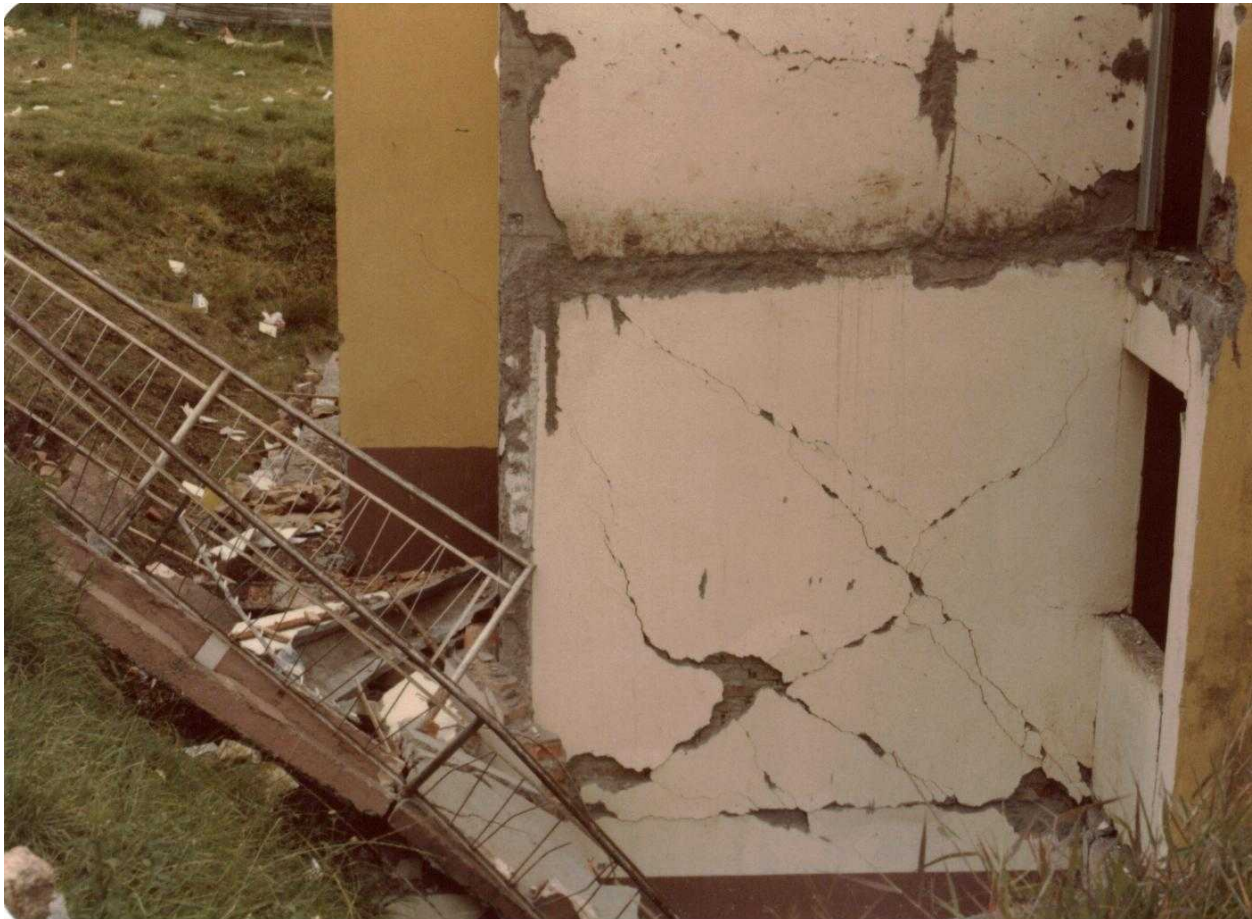
*FIGURE 6H: Typical Earthquake Damage - Importance of the Details in Seismic Design : The "access bridge" to this building did not have adequate bearing length and had collapsed, thus leaving inhabitants without a means of escape*

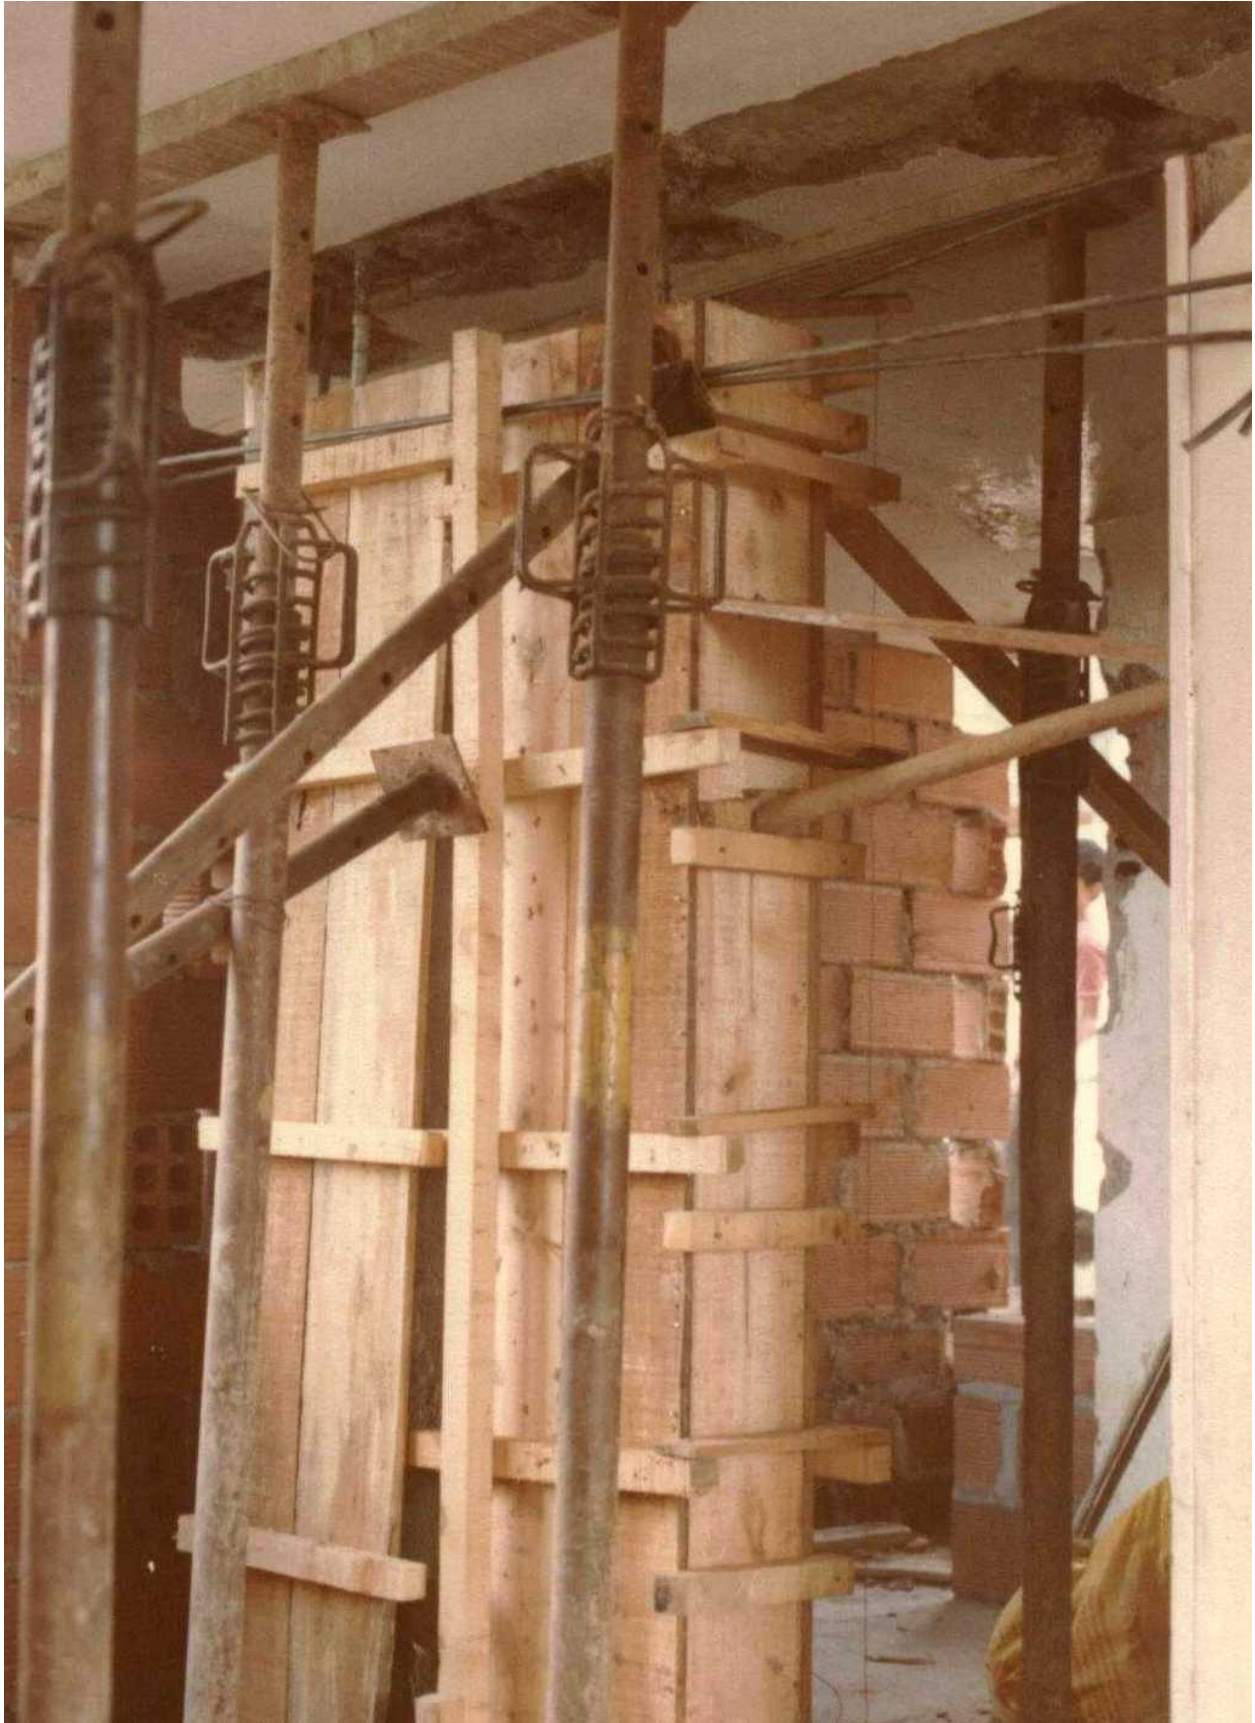
*FIGURE 7A: Seismic Strengthening Techniques-Installation of New Concrete Tie Columns*

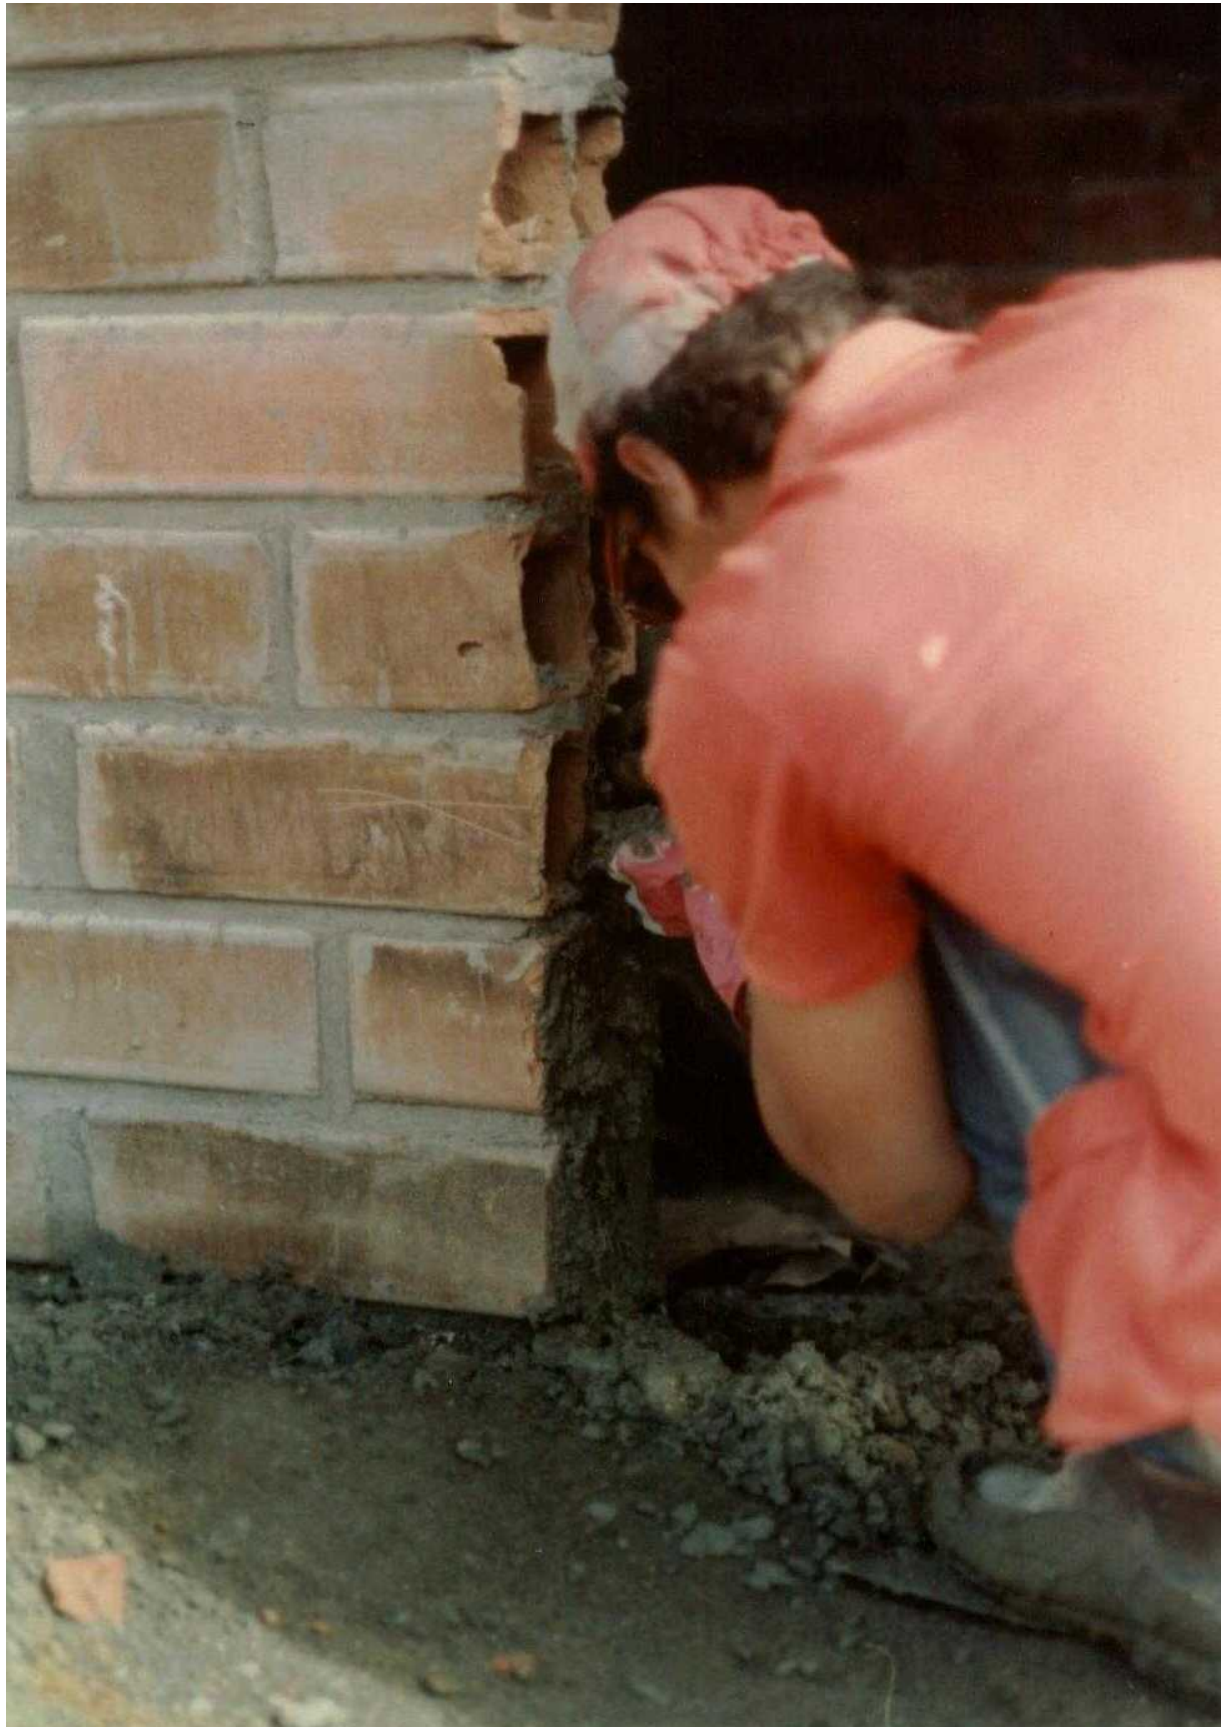
*FIGURE 7B: Seismic Strengthening Techniques - Installation of New Concrete Tie Columns*
